**RESEARCH REPORT NO. 1**

**RESISTANCE OF UNDERGROUND AND BURIED HYDRO-TECHNICAL  
CONSTRUCTIONS IN CASE OF EARTHQUAKE**

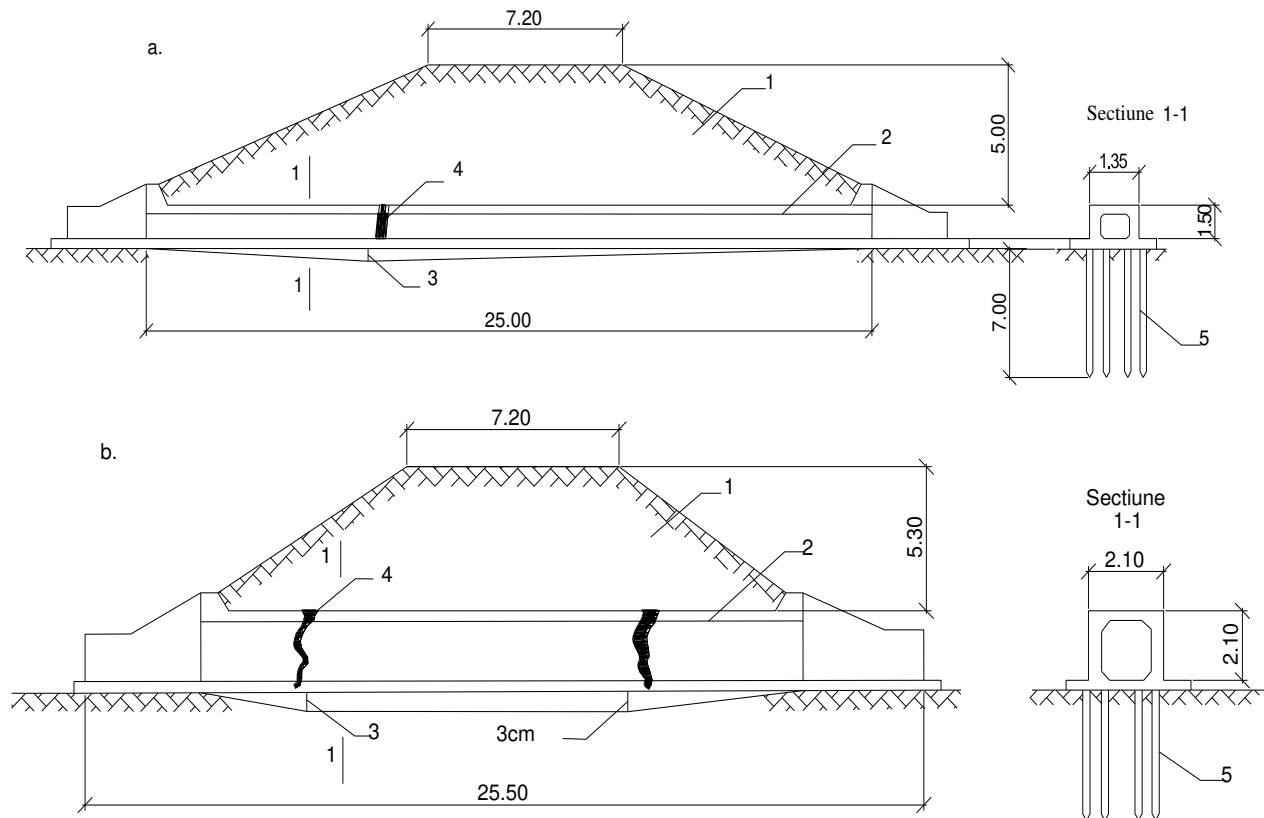
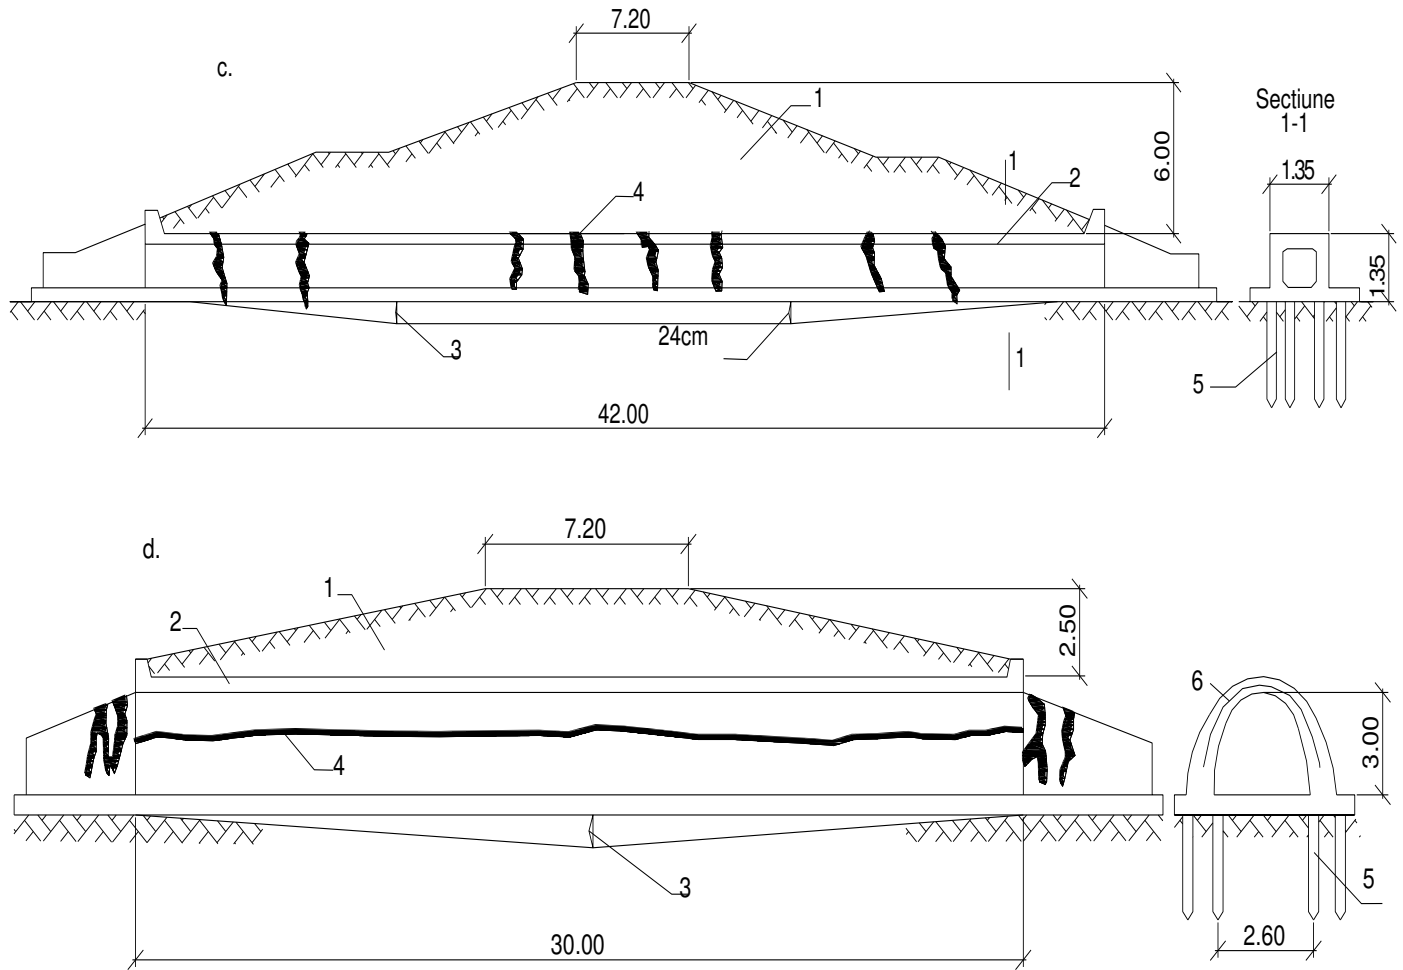
In Figure 2.1. there are shown some types of damages found. Thus, uneven and high amplitude subsidence (1 to 24 cm) of pipelines were identified.

Due to the position of the piping lengths, a single crack in the middle (fig.2.1.a), two cracks approximately symmetrical to the middle (Fig.2.1.b), numerous cracks distributed generally uniformly along the length (Fig.2.1.c) occurred.

Fig.2.1.Damages caused by the Kanto earthquake at the drainage pipes of the river banks:  
a-unique cross-section crack, b-two cross-section cracks, c- cross-section cracks uniformly distributed along the length, d-longitudinal crack, 1-pier, 2-drain line, 3-subsidence, 6-fitting.

In the reinforced concrete pipe (fig.2.1.d) a single longitudinal crack occurred along the length of the vault and sloping cracks in the lateral walls of the portal. Damage shows a high load from the additional horizontal overpressure pressure in the transverse direction of the pipeline.

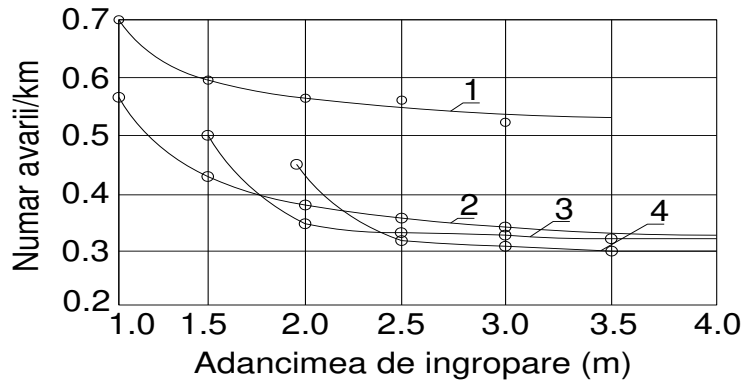
Fig.2.2. Variation of damage / km with depth

Another issue analyzed during the Tashkent earthquake was that of the depth of pipe laying on their earthquake resistance. Figure 2.2. shows that in the case of cast iron pipes the number of damages depends on the number of burial depths. It is noted that the number of damages per linear meter decreases proportionally with the increase in burial depth.

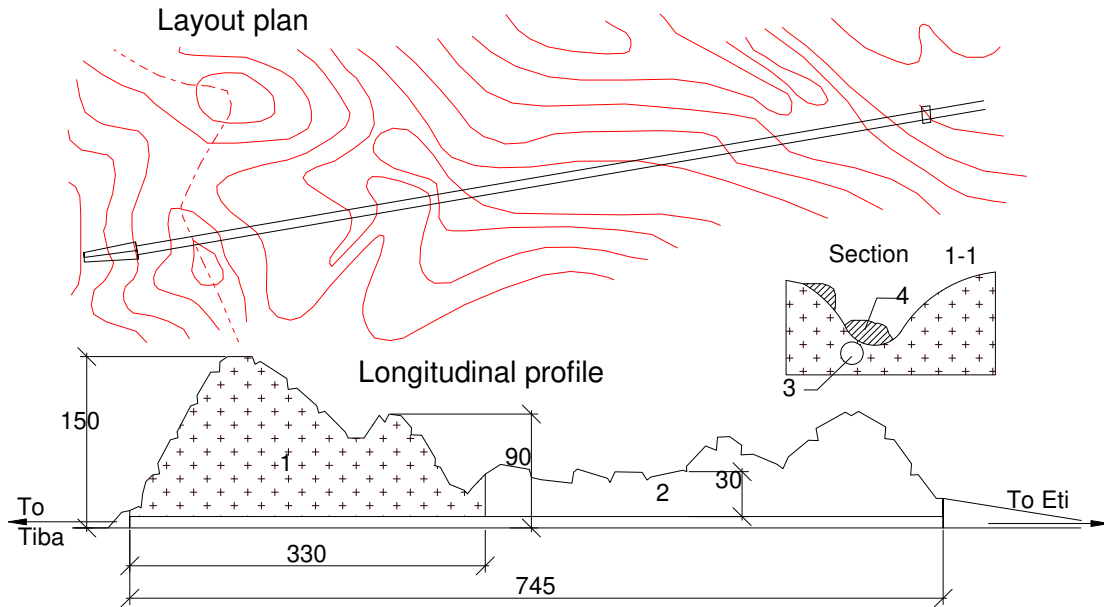
Fig. 3.3. shows the Namuya single-track tunnel, 745 m long, built 5 years before the earthquake. It crosses an area of hills lying along the seashore, the middle sections of the trail undercrossing water courses. The rocks in the area of the route are tertiary-tufted formations, tophus shrubs and sandstones.

Fig.3.3.Namuya tunnel damaged by the Kanto earthquake:  
1-tophus, 2-tophus rocks, 3-tunnel, 4-aquifer fields.

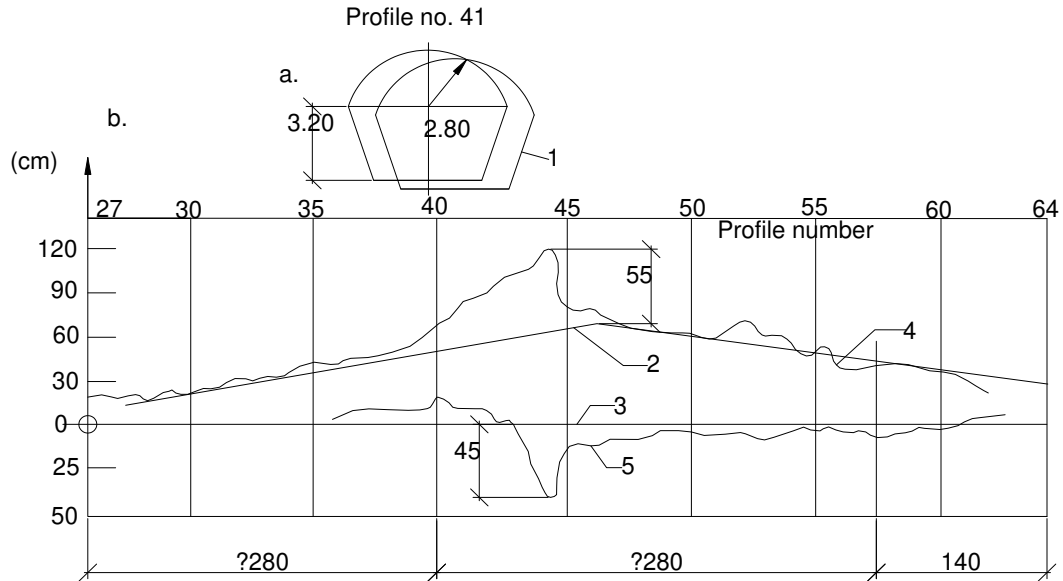
Not so easy to explain are the horizontal displacements of the tunnel excavation, 5-8 cm to the mountainside, in the area 200-300 m from the left portal (Fig.3.4).

Fig.3.4.Namuya tunnel damaged by the Kanto earthquake:  
a-cross-section, b-longitudinal profile displacements,  
1-shifts after earthquake, 2-original profile, 3- initial axis  
4-vertical displacements in axis, 5-horizontal displacements in axis.

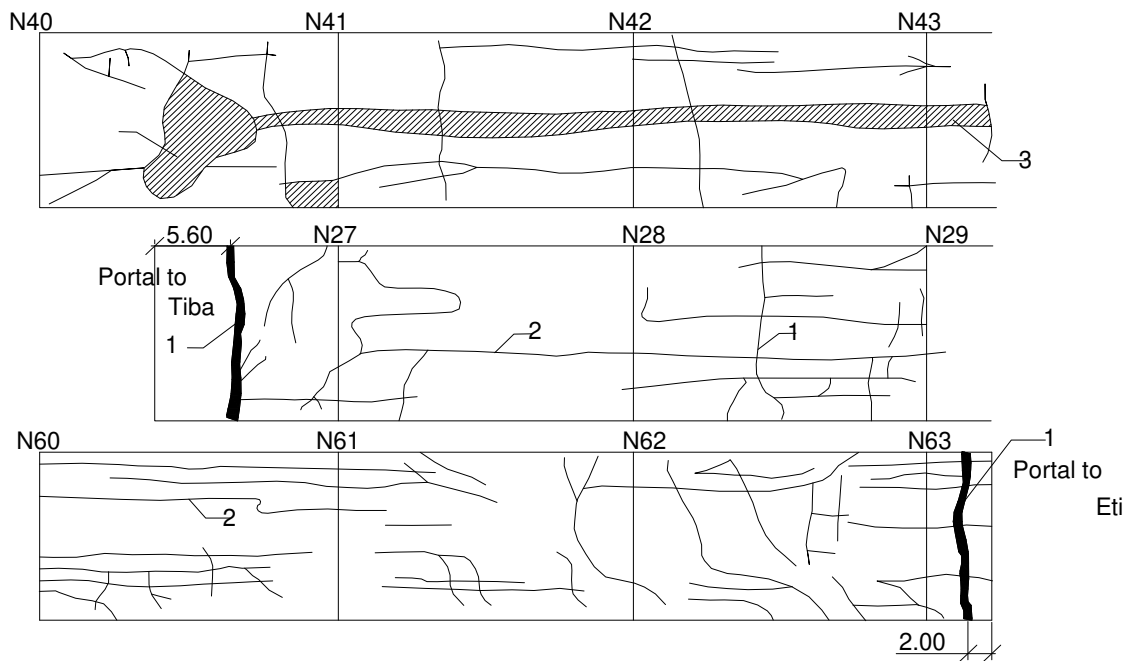
Cross-section cracks have formed in the vicinity of the portals. Larger degradations, in the form of cracks and faults, wall collapses, vault collapses with rock penetration into the tunnel, have occurred especially in areas with tophus rocks and lower tunnel depths (Fig.3.5)

Fig.3.5.Namuya tunnel - Kanto earthquake cracks and crashes:  
1-cross-section cracks, 2-longitudinal cracks, 3-vault collapses.

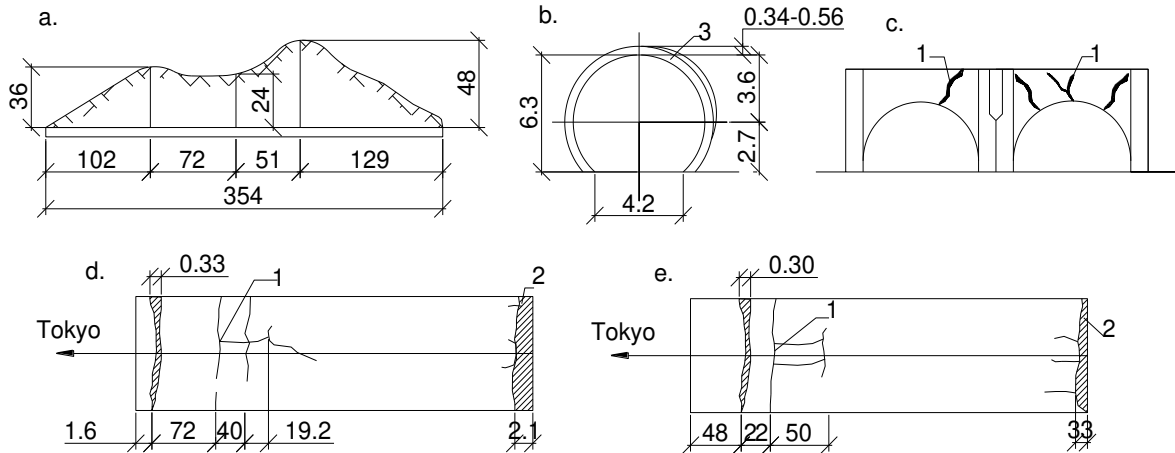
The earthquake caused numerous cross-section cracks and faults in the portal area, on sections up to 60 m (fig.3.6.c, d, e).

The structure has moved outward in many places, and on a 16.5 m sector it has moved upwards. It has been found that the damage decreases as the depth of the tunnel increases.

Fig.3.6. Hakone tunnels - Kanto earthquake damage:  
a-long profile, b-type cross-section, c-damage to portals, d-damages to the vault  
1-faults, cracks, 2- vault crash, 3- remnant movement.

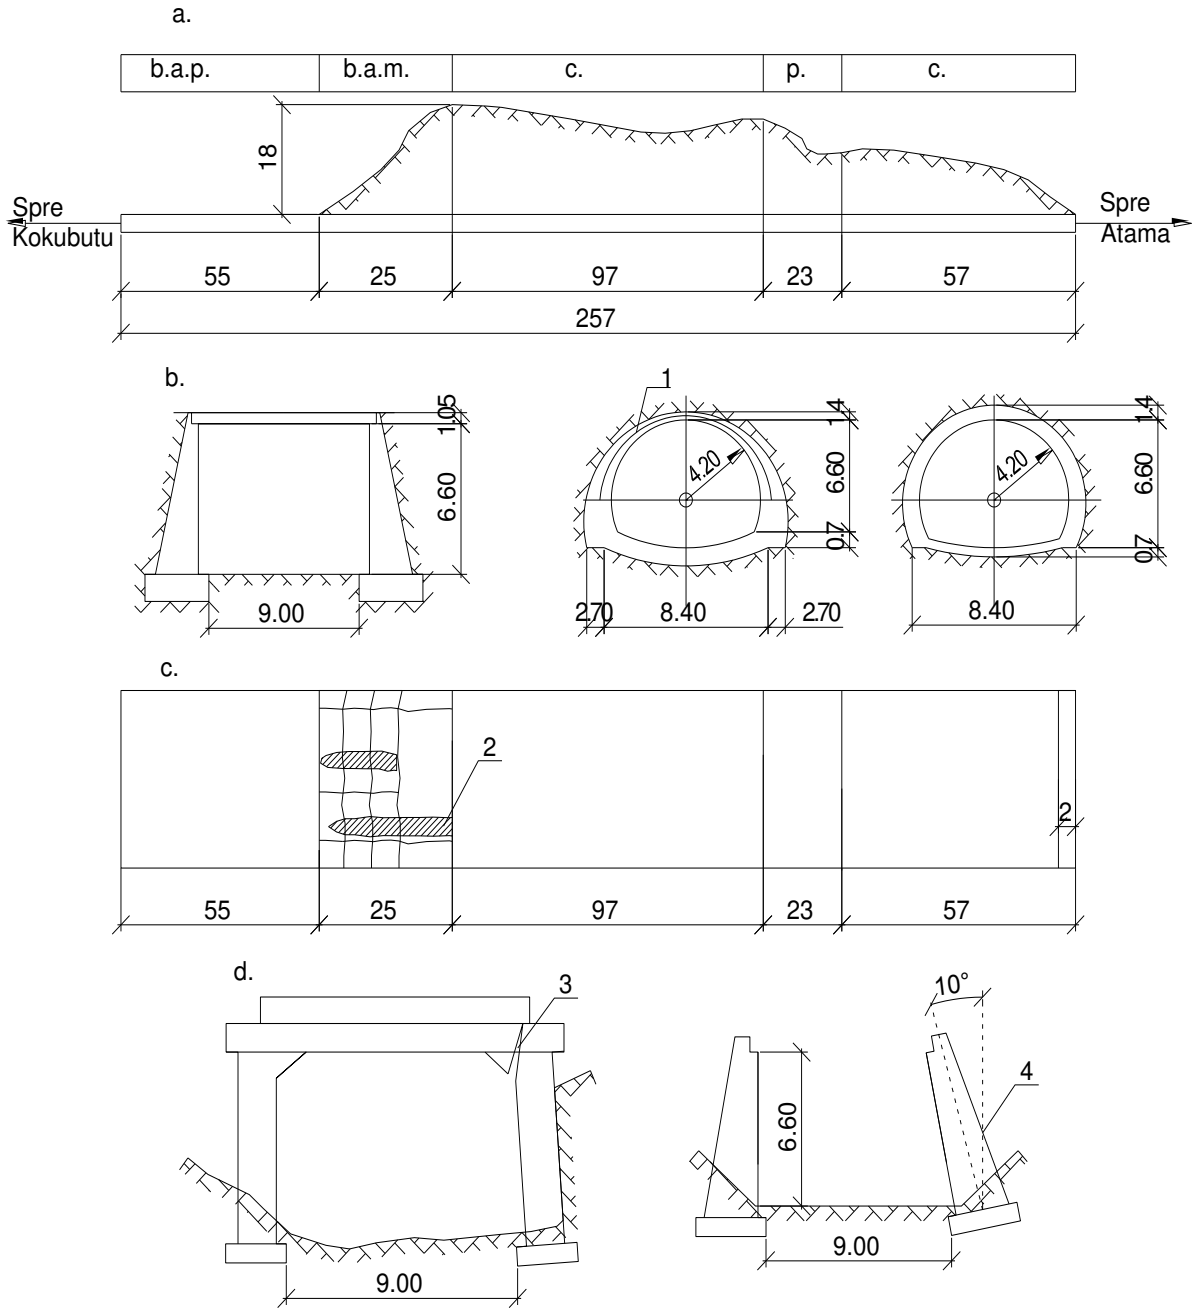
As a result of the earthquake, both supporting walls moved inward, and a wide crack appeared on the face of the left portal. In the areas where the tiles were not installed, large rotation of the supporting walls was found (Fig.3.7)

The most important damages in the covered area of the tunnel occurred in the reinforced concrete section, located at a small depth (fig.3.7.c) and not in the masonry structure, located at a greater depth, where a single larger crack appeared at a distance of 7 m from the right portal.

There have been numerous cracks in the structure, with depths of up to 10 cm. This leads to the conclusion that the low depth of the tunnel and the large declivity of the mass above it negatively influences the stability of the tunnel at seismic loads.

Fig.3.7. The Kominé tunnel - the Kanto earthquake:

a-long profile, b-cross-section type, c-damage to the vault and walls, d-damage in the area with lining of prefabricated concrete; 1-reinforcement, 2-cracks and holes in the vault, 3-cracks, 4-rotating supporting wall; prefabricated reinforced concrete b.a.m.-concrete, monolithic reinforced concrete, c-brick, d-stone.

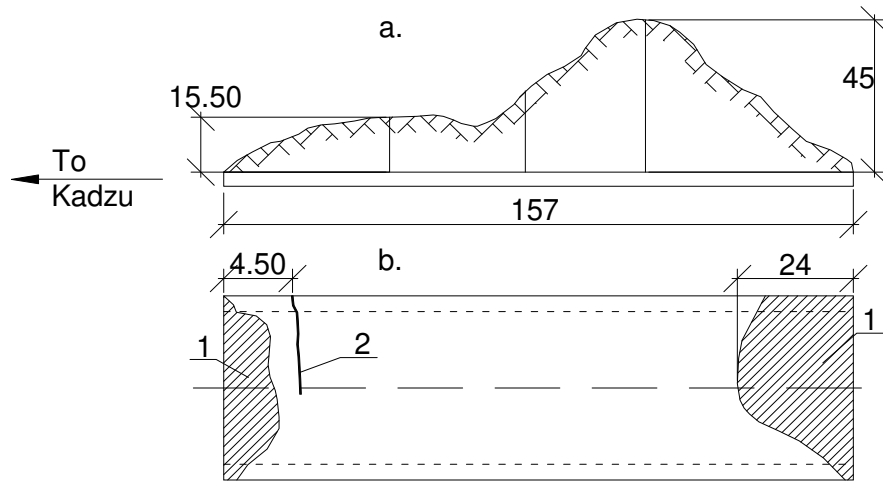
- stone wall collapses and stone masonry abutments that strengthen the inner wall in the left portal area.
- Cross-section cracks in the left wall in the left portal area.
- the collapse of the stone masonry vault in the right portal area.

These damages are believed to have occurred due to slipping phenomena from the slope. Significant damage has occurred in 11 tunnels on the Atamy line. They have a horseshoe-shaped lining for double track and were built on the slopes. The lining is made up of 60-...100 cm thick stone.

Fig.3.8. The destruction of the portico of a railway tunnel at the Kanto earthquake:  
a-profile in the long, b-damage to the vault, 1-crashes, 2-cracks.

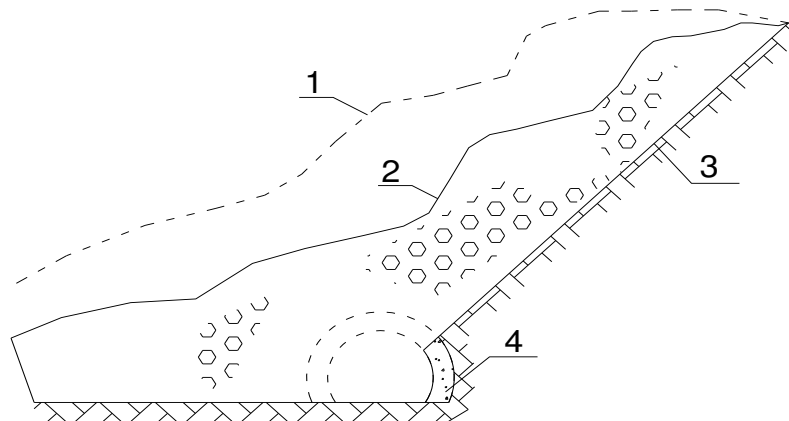
Fig.3.9. Destruction of a coastal tunnel upon the Kanto earthquake:  
1- land line before earthquake, 2-slope collapse,  
3-line restoration of the slope after the earthquake, 4- remaining part of the lining.

During the earthquake, the tunnel parts in the vicinity of some portals were destroyed by the collapse of the slopes in lengths of tens of meters. On the rest of the length of the tunnels, in the sections between the vault and walls, numerous cracks have formed.

The route was restored in the area by a suitable slope (Fig.3.9)

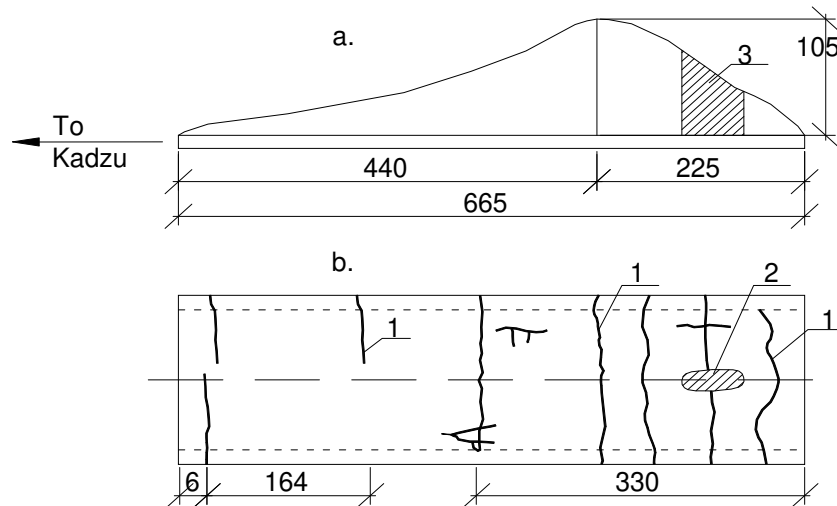
Types of seismic damage are also illustrated in Figure 3.10 showing the damage caused by the Kanto earthquake to a railway tunnel with a stone masonry lining on the Kodzu line. Main breaks consist of:

- vault collapses,
- cross-section and longitudinal cracks, especially in the vicinity of the portals,
- residual deformations in cross-section.

Fig.3.10. Kodzu tunnel - damage upon Kanto earthquake:  
a-longitudinal profile, b-damage to the vault and walls, 1-cracks,  
2-vault collapses, 3-fallen area.

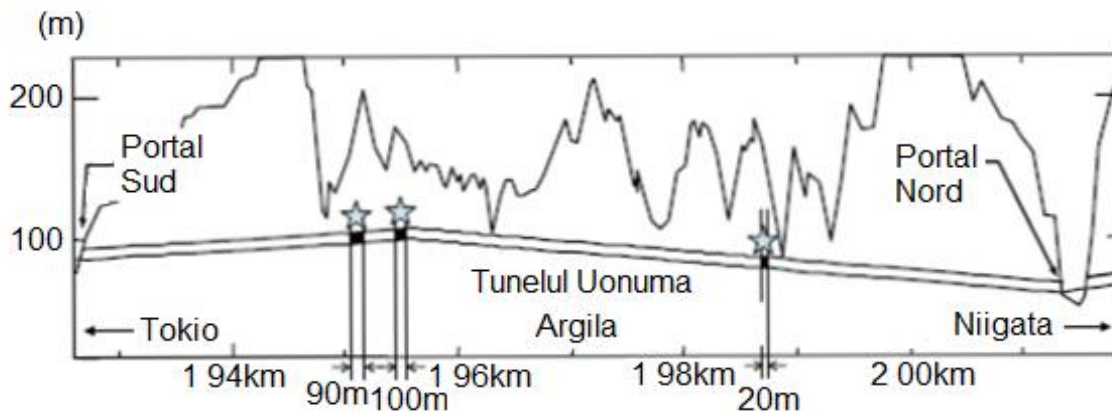
Fig.3.13 Synoptic Profile of Uonuma Tunnel, with emphasis on the three sections in which it suffered serious damage.

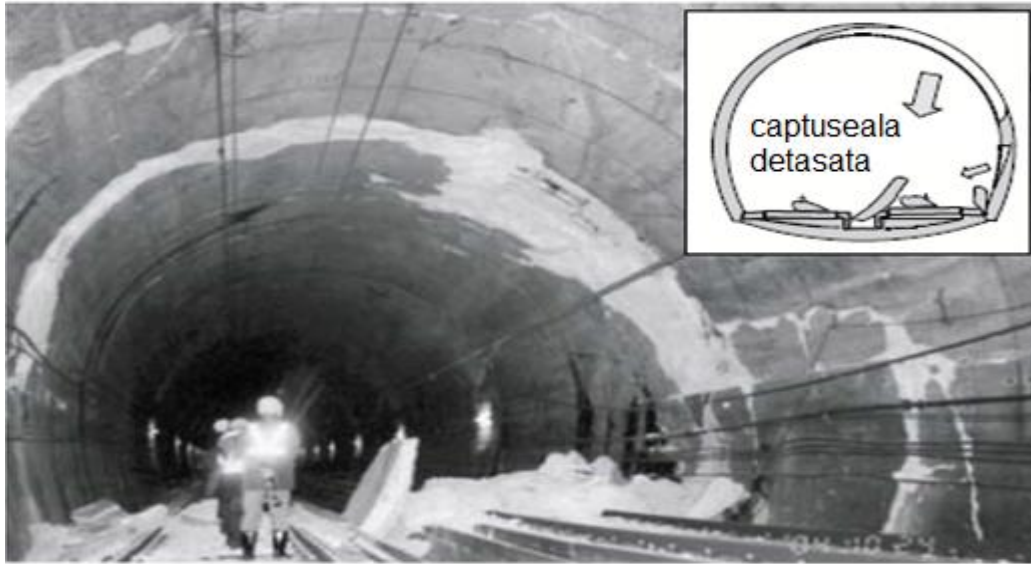
Figure 3.14 shows the most severely affected section, there was damage to the concrete coating that fell apart and fell on the track. The largest block of detached concrete was about 2 m<sup>3</sup> weighing about 5 tons. Other damage was observed at a narrowing of the section of the tunnel.

Fig.3.14 Damage to the Uonuma tunnel.

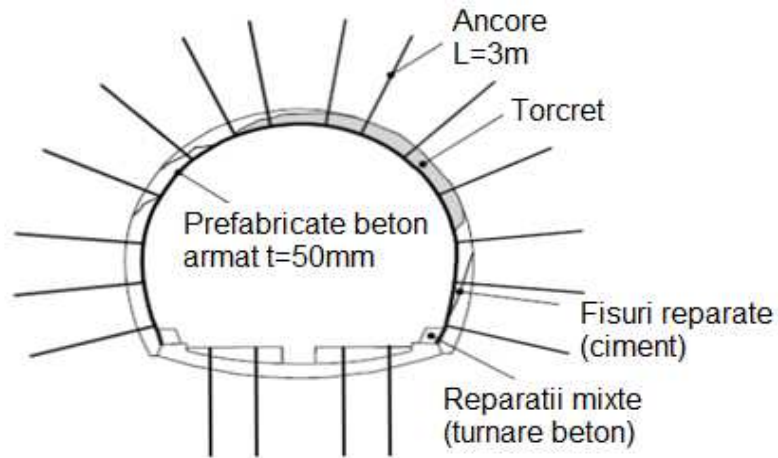
Fig.3.15 Repairs to the Uonuma tunnel

The tunnel was in a critical state, it was closed for two months for repairs, it was necessary to break and remove degraded concrete being replaced by prefabricated reinforced tiles, tunnel repairs are shown in figure 3.15.

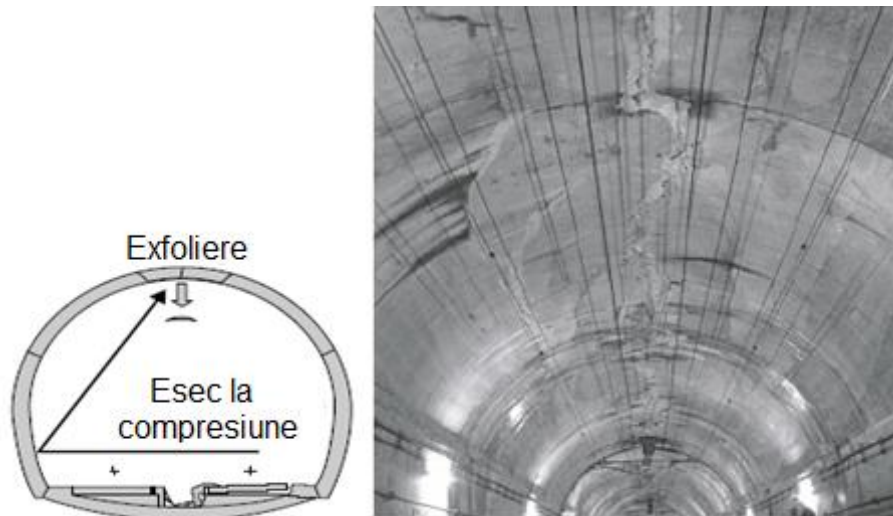
Damage also occurred at the Myoken tunnel, which suffered longitudinal cracks on a distance of about 50 m (Fig.3.16) and some exfoliations of the coating.

Fig.3.16 Damage to the Myoken tunnel

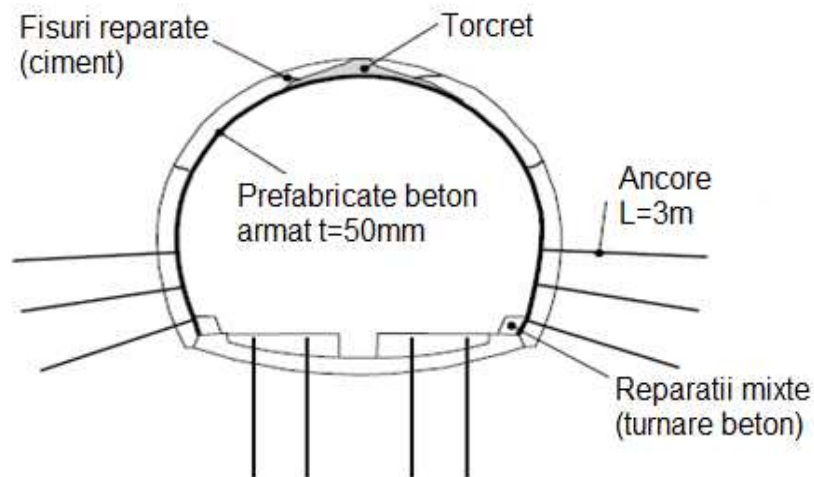
Fig.3.17 Repairs to the Myoken tunnel

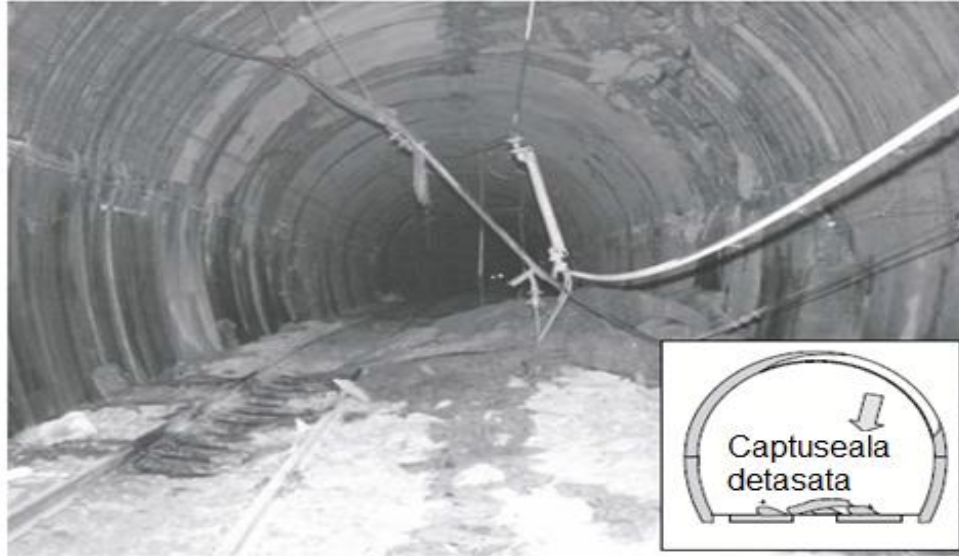
The Wanatsu tunnel suffered due to seismic actions, with about 40 m long longitudinal cracks and large blocks of concrete detached from the coating (Fig.3.18).

Fig.3.18 Damage to the Wanatsu tunnel

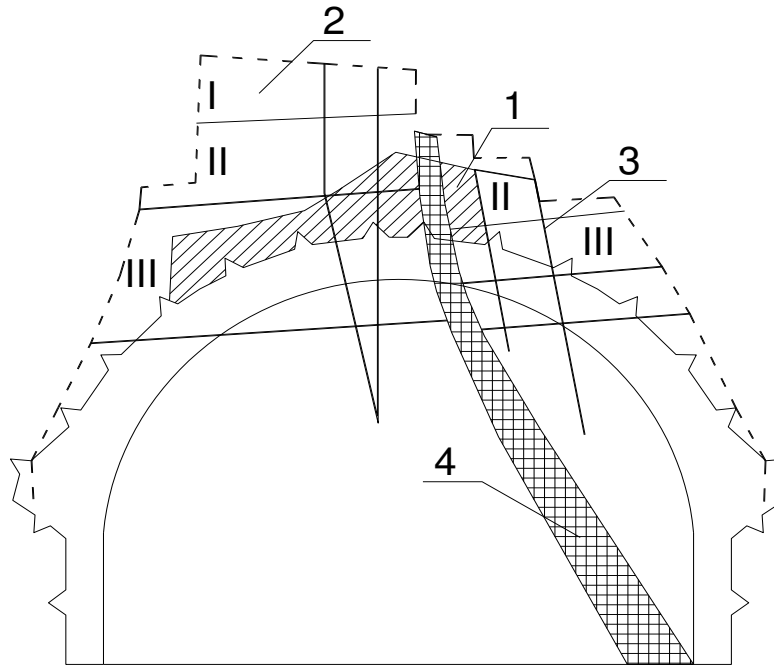
Important damages occurred in the crossing area of the fault by the car tunnel (Fig.3.20

In the rock massive there appeared cracks with openings from 0.5 to 1.0 m. Directions of these cracks formed sharp angles or 90° with the tunnel axis. The rocks in the area are different, from poorly to strongly cracked, predominantly poorly cracked rocks.

Fig.3.20 The collapse of the vault at the UH Cirkeisk tunnel:  
1-collapse after the opening of the excavation, 2-collapse after the earthquake,  
3-open cracks, 4-tectonic fault, I, II, III-clay layers.

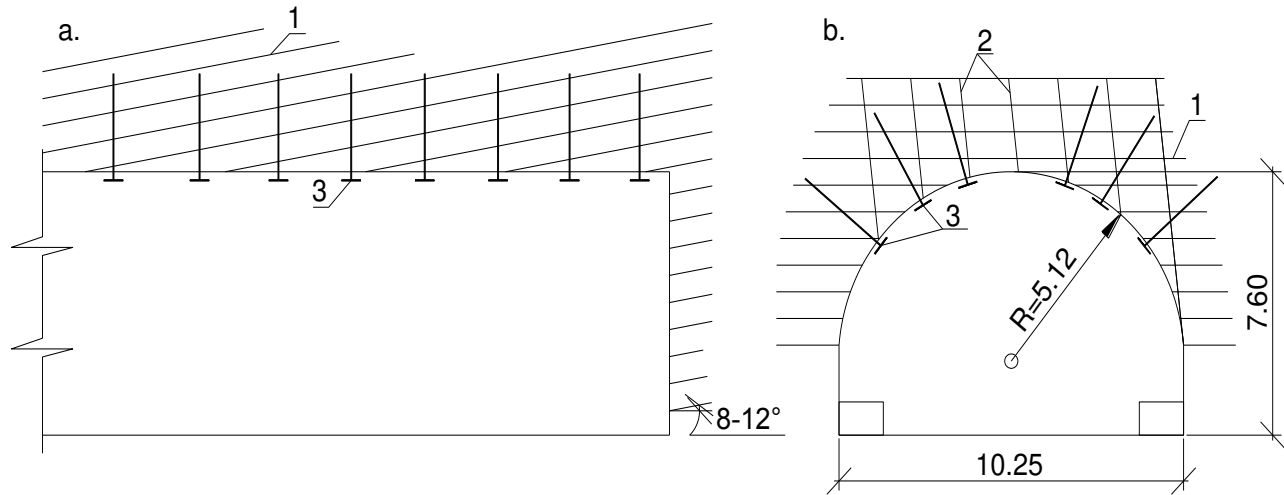
The most significant rock collapse, with a volume of approx.30 m<sup>3</sup>, occurred, with the anchors and the reinforcement mesh, from the escape galley vault. Throughout its route there have been identified exfoliations of small pieces of rock or fillings from tectonic cracks, rock drops from the walls and excavation vault, cracks in the hearth and the walls of reinforced concrete lining with openings up to 10 mm. Some crashes can be explained by fragmenting the rock into blocks separated by normal tectonic cracks or along the plane of schist (fig.3.21).

It has been found that anchor support has yielded to several areas. It results that the anchors did not sufficiently support the rock packages above the gallery, avoiding the relative displacements between the layers. Anchor supports are considered to be applicable only to temporary works.

Fig.3.21). Anchoring of tunnels and galleries excavations at U.H.Cirskeik:  
a-long section, b-cross-section,  
1-direction of schist plans, 2-tectonic faults, 3-anchors.

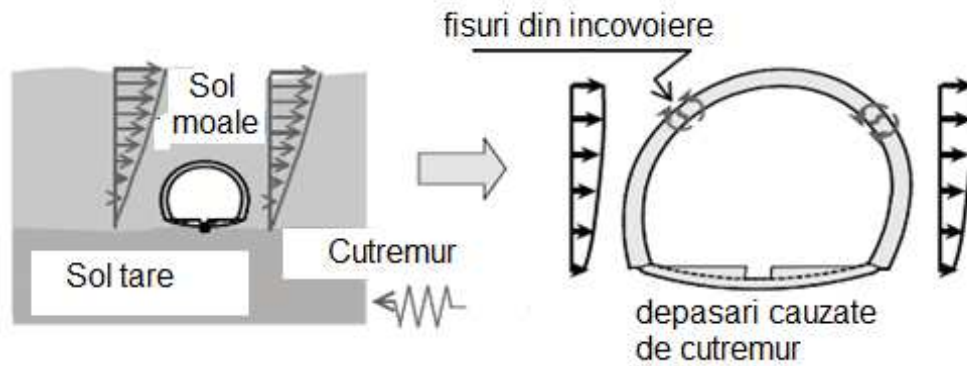
- Type 1 - damage to shallow-depth tunnels (fig.4.3)

They are likely to be affected by earthquakes as they are often built into loose lands, where the seismic action is amplified by the large deformation of the land. In these tunnels there are often cracks in the vault due to the bending moments.

Fig.4.3 Type 1- shallow-depth tunnels

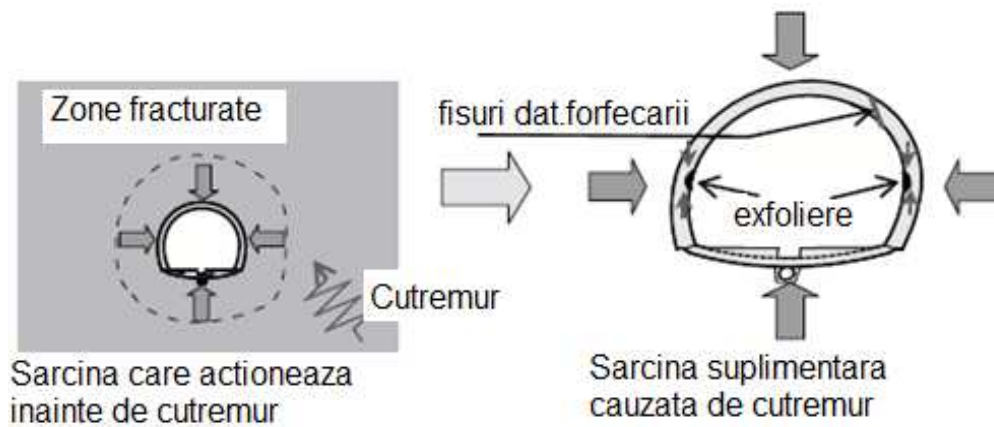
- Type 2 - Damage to tunnels due to poor geological conditions (Fig. 4.4)

This type of damage is visible in tunnels built in soft land, such as fractured areas, sometimes in tunnels with great land coverage. In fractured areas, the soil is soft and has a great displacement during the earthquake, and it also acts as a charge upon the coating.

Fig.4.4 Type 2 - Tunnels built under precarious geological conditions

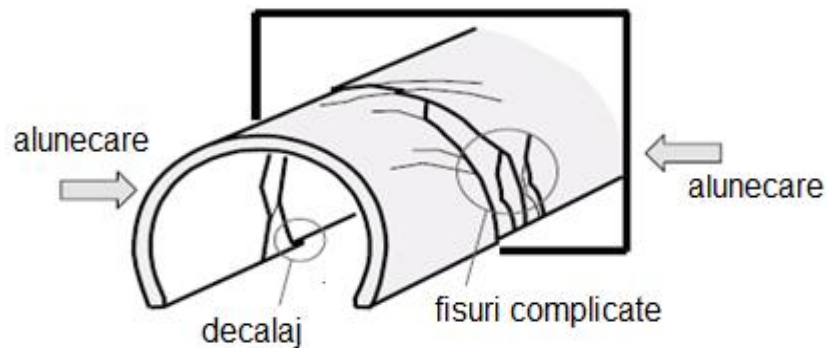
- Type 3 - Damages that occur when an earthquake crosses a tunnel (fig. 4.5)

This type of cracks often appear due to shearing and cracks in round slices.

Fig.4.5 Type 3 - Damage caused by earthquakes acting across the tunnel

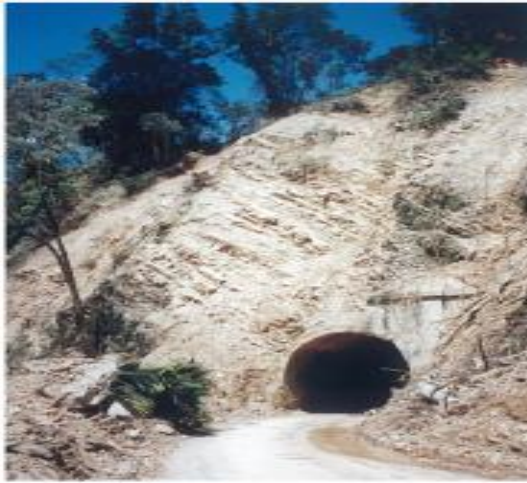
One of the frequent problems caused by earthquakes in tunnels is the insufficiency of the slope above the portal (fig. 4.8). It is important to consolidate the slope or build a protective structure.

Fig.4.8. The portal of the Haguro tunnel

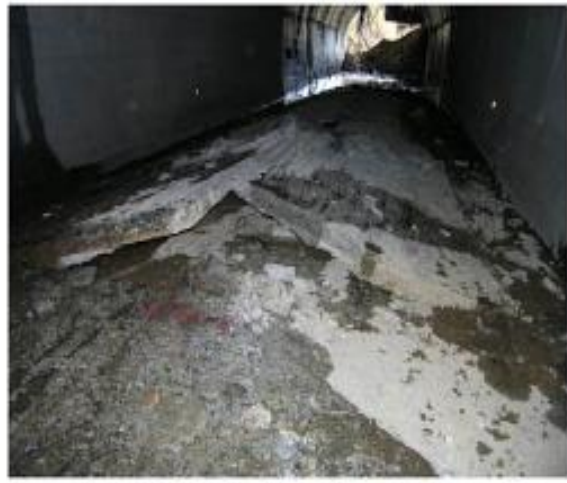
Fig.4.9. Exfoliations of the coating in the Haguro tunnel

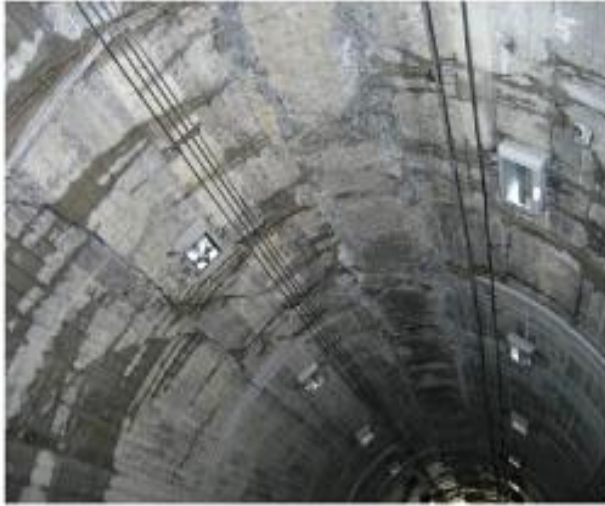
Fig.4.10. Extended longitudinal cracks in the Haguro tunnel.

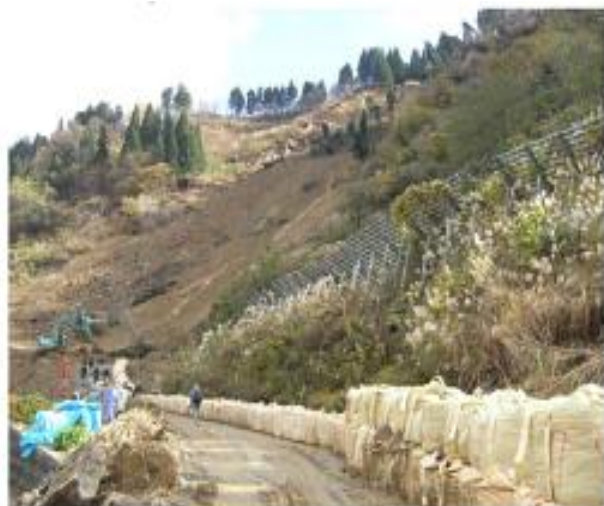
Fig.4.11. Land sliding near the western entrance of the Haguro tunnel.
