## Research report No. 2

### THE HISTORICAL MAJOR EARTHQUAKES FROM ROMANIA AND THEIR CONSEQUENCES ON BUILT ENVIRONMENT

Eng. Daniel-Ioan DIMA

June 2014

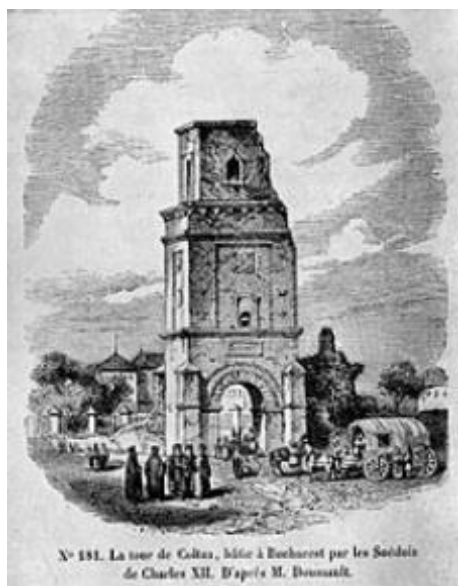
Among the churches and monasteries that suffered from the earthquake, it is worth to mentioning: Colțea (Figure 6), Stavropoleos, Săririndar, Sf. Apostoli, Sf. Gheorghe Nou, Mihai Vodă, Sf. Atanasie-Bucur, Cotroceni monastery and Văcărești monastery [8]. The Șerban Vodă Inn [15] was also demolished, i.e. the in where the National Bank is today. All culminated with effects on the environment „... the opening of the earth, water coming out of the earth and in some places ... tar...”[9].

Figure 6 - The collapse of part of the Colțea tower

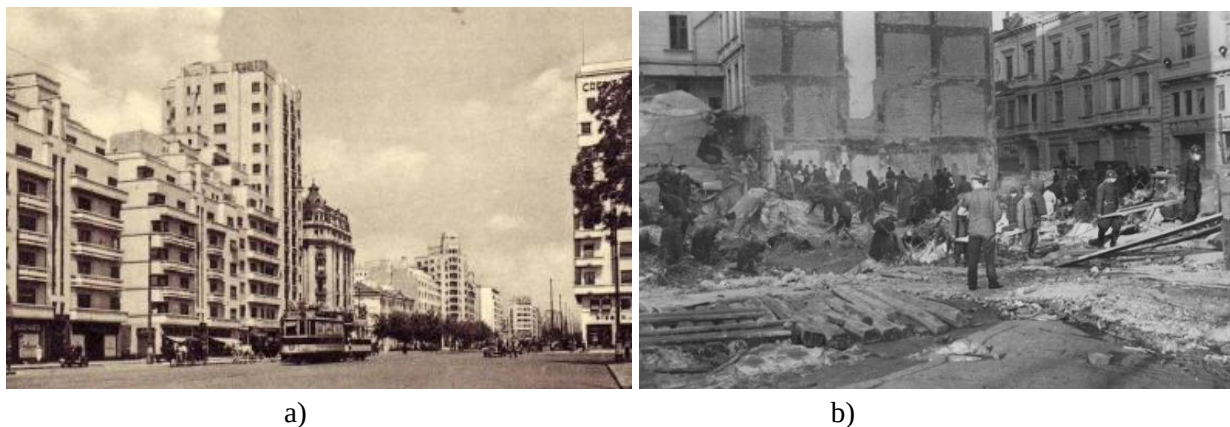
The earthquake was characterized by serious consequences both in terms of casualties, over than 350, and in terms of significant property damage. In Bucharest, the most significant destruction was the complete collapse of the Carlton Block, which was the tallest reinforced concrete construction in Romania at that time (47 m high, 12 floors).

Figure 8 – Carlton Block: a) before the 1940 earthquake; b) before the 1940 earthquake

Damage was also noticed at the level of the beams (cracks, dislocated concrete, flamed reinforcements, etc.). The filling masonry also suffered dislocations and cracks, due to a low tensile strength and a poor connection between it and the reinforced concrete elements. The buildings, where the masonry was made at the same time as reinforced concrete, behaved very well. The collapse of the Carlton block was the most unfortunate event.

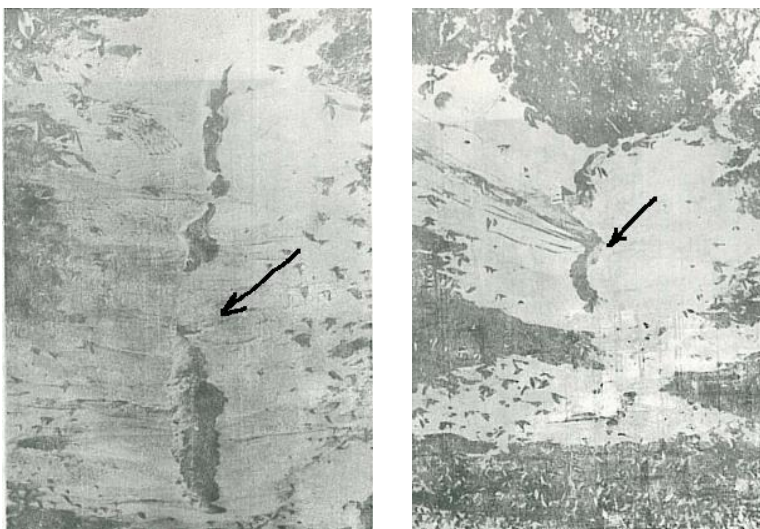
In general, major seismic phenomena lead to the onset of complex associated phenomena such as fires, floods, landslides, landslides, avalanches, etc., which often amplify the extent of damage to the built environment. The earthquake of March 4, 1977, declassified a series of complex phenomena, among which the most important were the typical geological phenomena for the Vrancea earthquakes, namely: i) fractures and cracks (Figure 25);

Figure 25 - Cracks with liquefied sand spring [10]

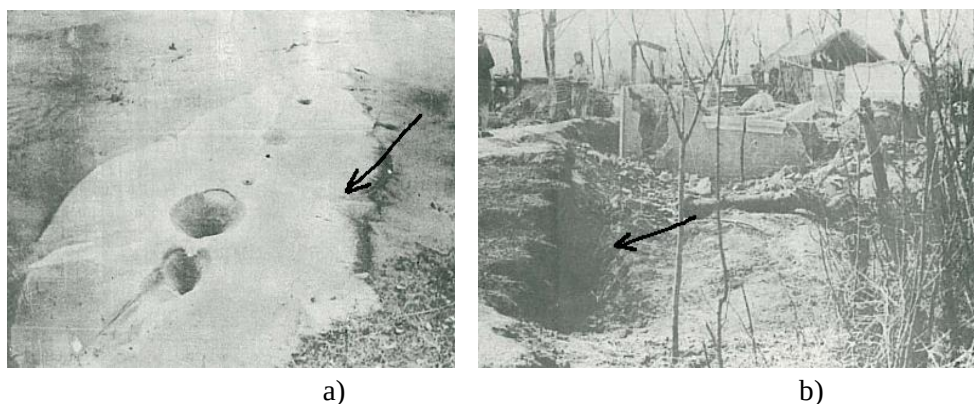
ii) cracks and fissures (Figure 26); iii) changes in the groundwater and surface water regime;  
iv) gas emissions and muddy volcanoes; v) increase of natural radioactivity; vi) liquefaction of  
aquifer sands; vi) landslides;

Figure 26 - a) liquefied sand; b) landslides [10]

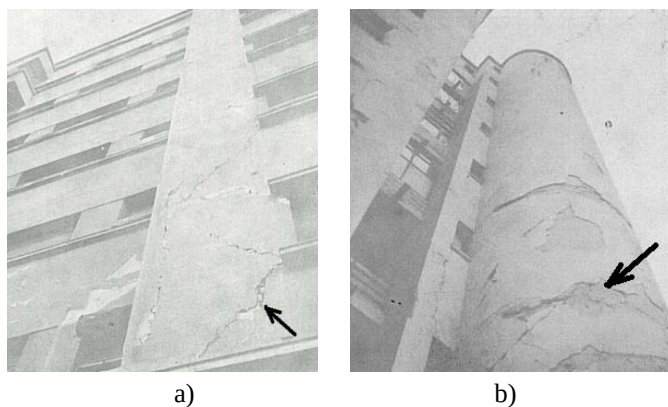
Figure 27 - a) Facade wall cracks; b) Masonry dislocated staircase [1]

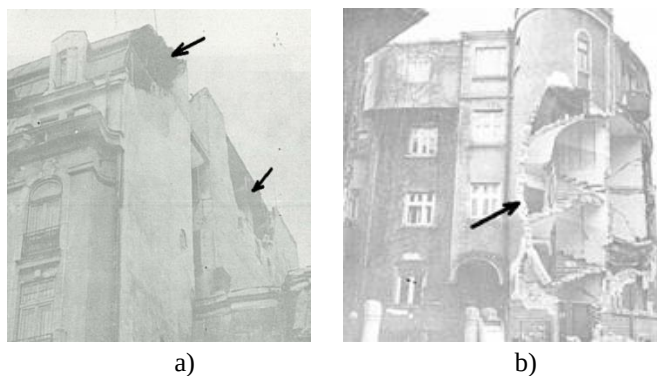
Figure 28 - a) Collapsed masonry heels; b) Facade masonry walls / collapsed staircase house [10]

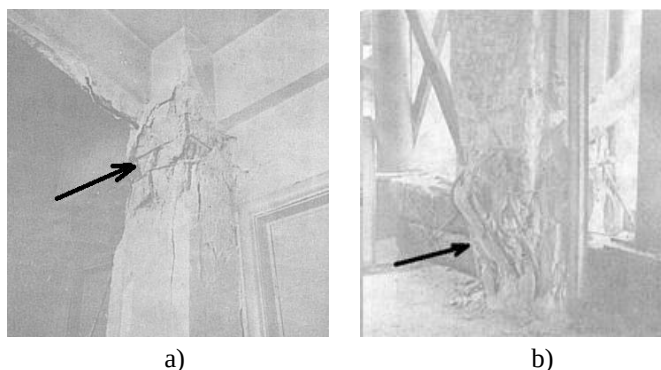
Figure 29 - a) Destruction of the column-beam node b) Destruction of the column at the base - ground floor [10]

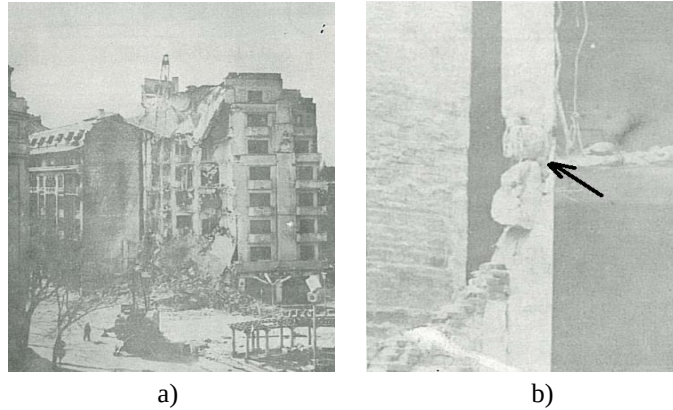
Most of them have suffered damage since the earthquake of November 10, 1940, damage that was either superficially repaired or neglected, and other causes (deficiencies in design, execution, inadequate quality materials, etc.) have led to severe damage or even collapse in the March 4, 1977 earthquake.

Figure 30 - a) "Lido" block of flats - Bucharest, building with reinforced concrete frame;  
b) Completely broken pillar - "Lido" block [10]

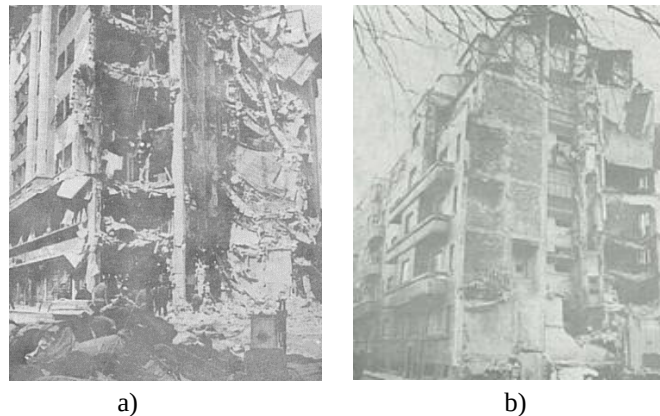
Figure 31 - a) "Danube" block of flats - Bucharest, building with reinforced concrete skeleton;  
b) Block of flats - Bucharest, Str. Poenaru Bordea no. 18 reinforced concrete frame building [10]

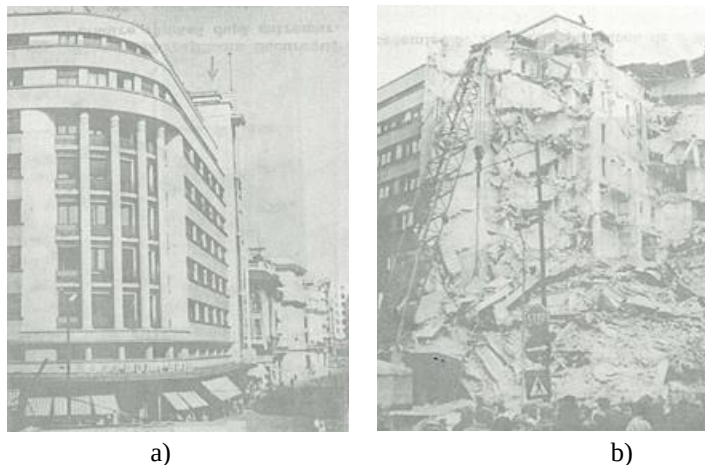
Figure 32 - Ministry of Metallurgical Industry ("Carpathian" Block) - Bucharest: a) before the earthquake; b) after the earthquake [1]

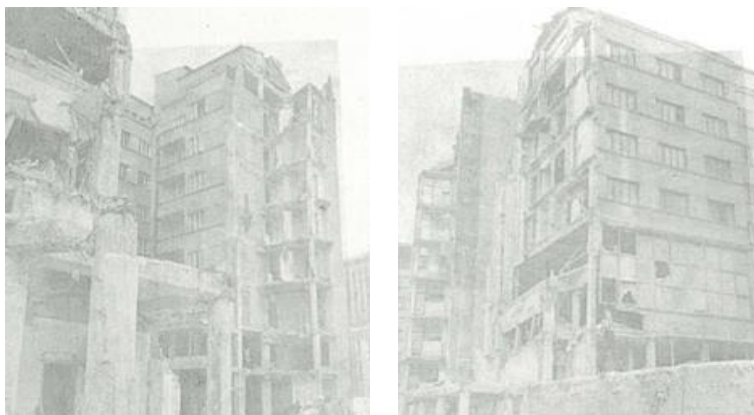
Figure 33 - The office block "Cofetaria Republica" (former Nestor) - Bucharest [10]

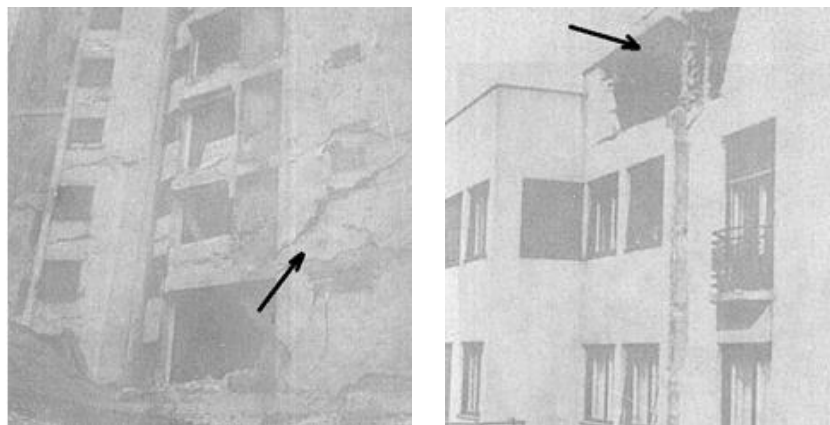
Figure 34 - Hotel "Ambassador" - Bucharest, damage to the facade [10]

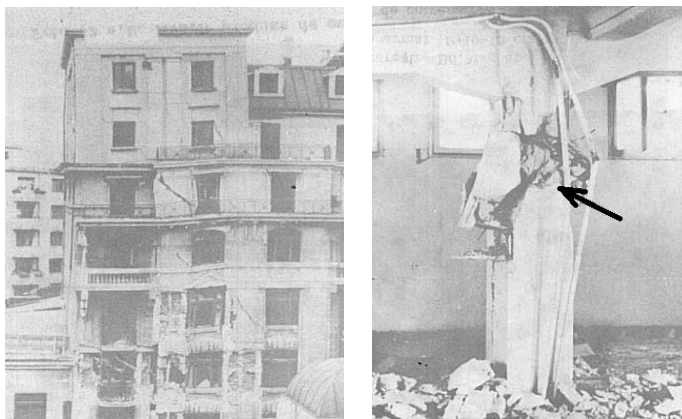
Figure 35 - Office building - ISPIF Institute - Bucharest, damage to the masonry on the facade, reinforced concrete bay windows and columns[10]

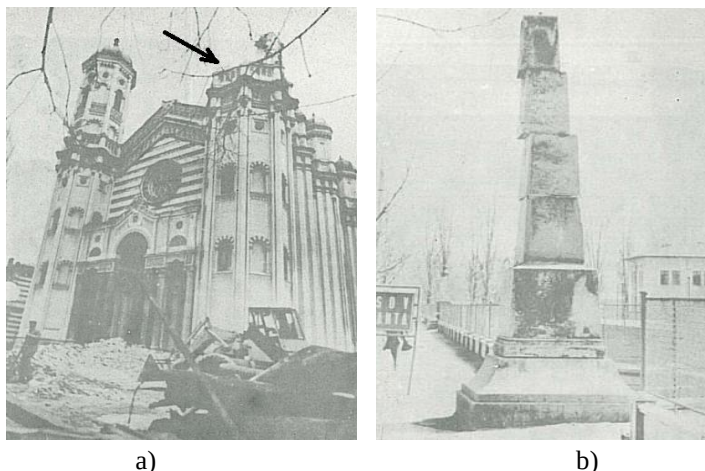
Figure 36 – a) St. Spiridon Church - Bucharest, right tower collapse; b) Obelisk from Bucharest located [10]

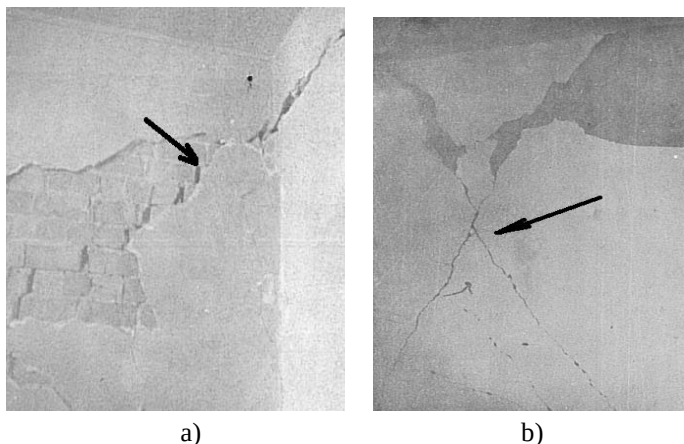
Figure 37 - a) Damage to load-bearing masonry walls; b) "X" shaped cracks in the reinforced concrete diaphragms [10]

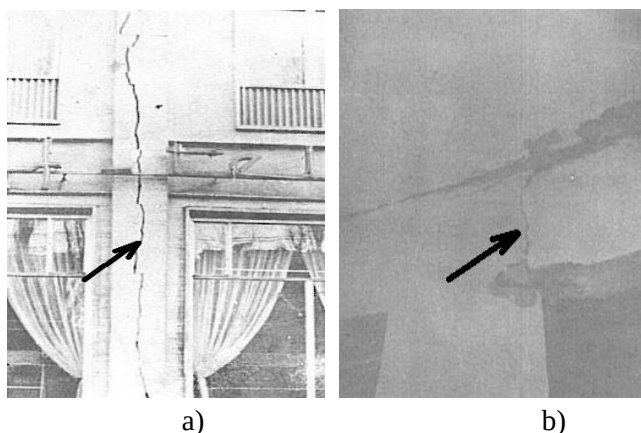
Figure 38 - a) Opening a joint in the facade; b) Breaking a beam in the area of the elevator house [10]

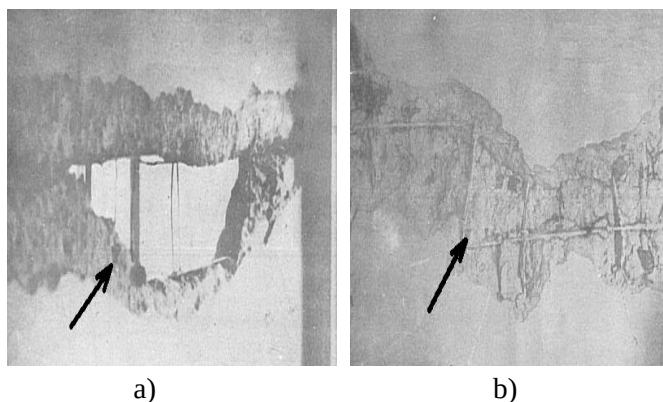
Figure 39 - a) Damages of a concrete diaphragm; b) Cracks and horizontal cracks with expulsion of the concrete coating layer to concrete diaphragms [10]

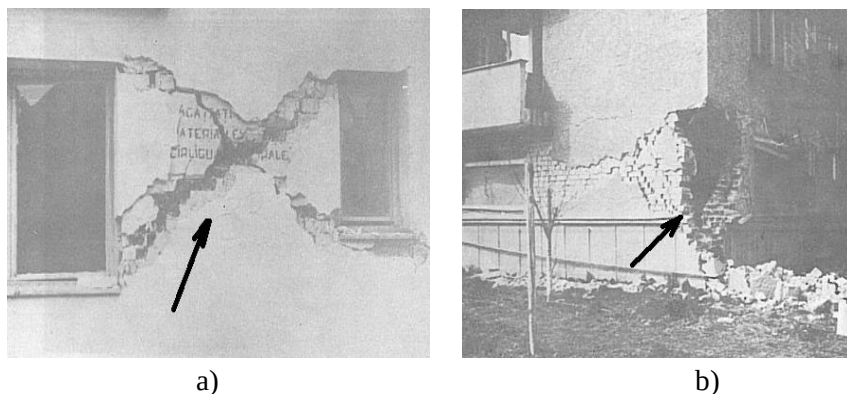
Figure 40 - a) Spindles for masonry washers; b) Damage to the exterior walls, there is a lack of concrete corner columns [10]

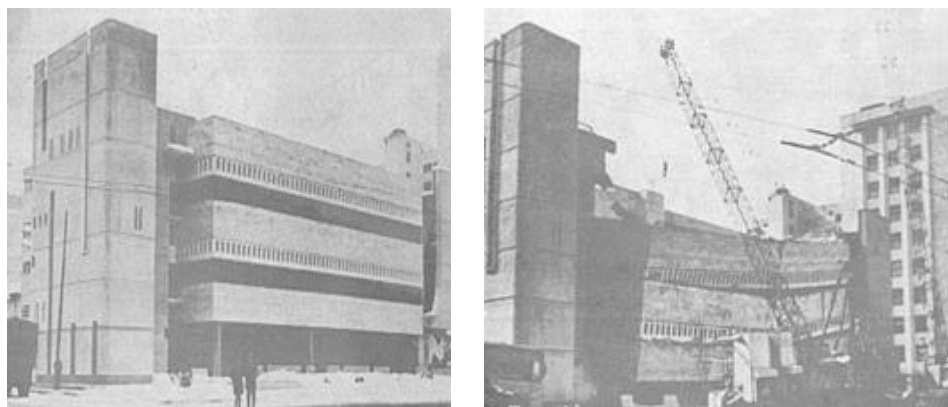
In general, it can be mentioned that a better behavior was found compared to the old ones, an isolated case was that of the collapse of the MTTc Computing Center in Bucharest (old building). Regarding the damages, they were specific to the structural typologies, including the isolated situations of collapses.

Figure 41 - Prabusirea cladirii Centrului de Calcul electronic MTTc, Str. Garii de Nord – Bucuresti; stap parter puternic avariat la partea superioara (sub capitel) [10]

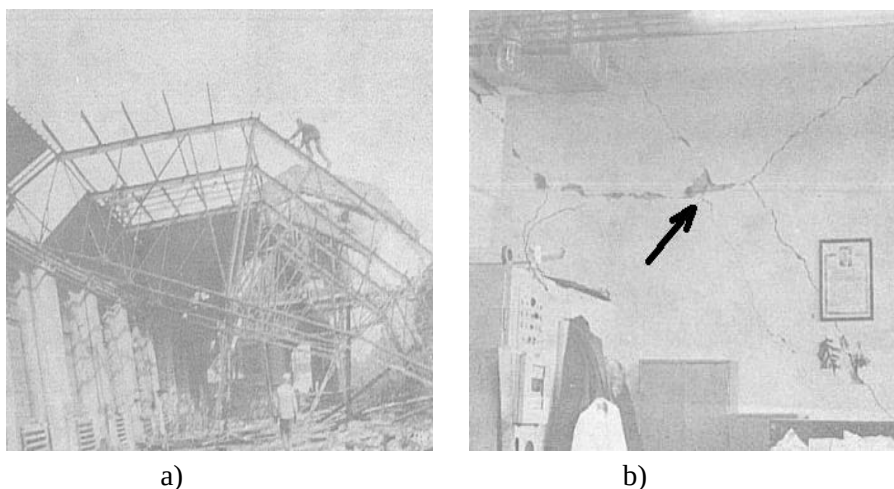
Figure 42 - a) Metal frame collapse - Petroleum equipment company, assembly hall - Prahova county;  
b) Cracks in the interior masonry walls, multi-storey frame building b.a. - ICCE Bucharest [10]

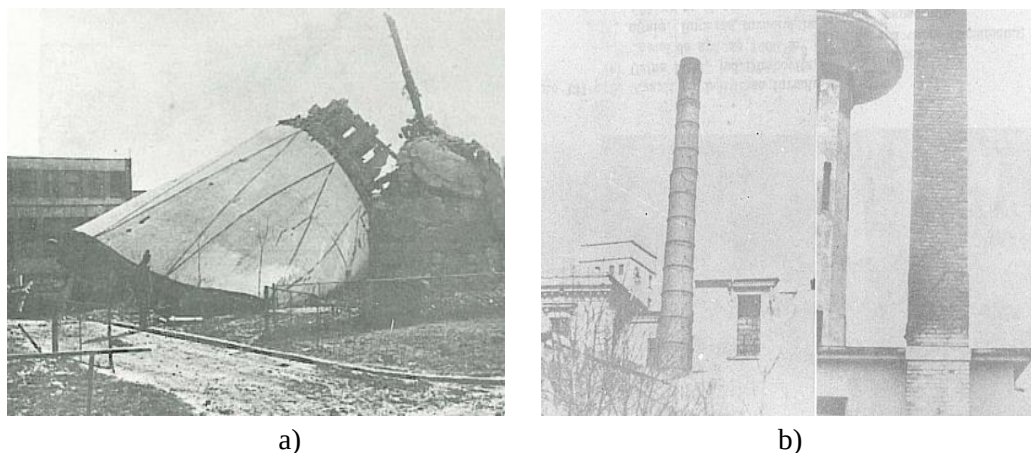
Special constructions (silos, bunkers, tanks, water towers, cooling towers, chimneys, external trusses for overhead cranes and walkways for conveyor belts), generally behaved well, locally registering situations of significant damage to the old chimneys made of load-bearing masonry and even complete collapses, and at the water towers, they represent a special category of constructions, registering in their case, situations of significant damages and even complete collapses (5 cases, 4 around Bucharest and a case in Pleasa - Ploiesti).

Figure 43 - a) Collapsed water castle, Kinescope Enterprise - Bucharest; b) Damages in the upper third of the chimneys in the masonry, Bucharest - Ilfov [10]
