Universitatea Tehnică de Construcții București

# INCIDENTS IN DAM AND DIKE BEHAVIOR INDUCED BY INTERNAL EROSION

Ph.D. Student  
Al Dulaimi Ali

2019

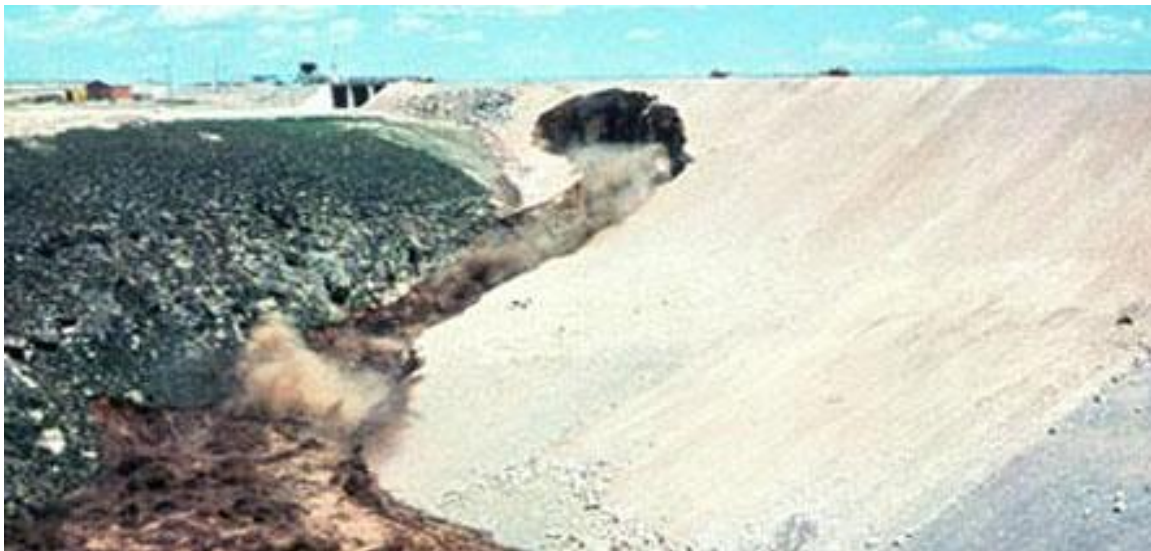
Teton dam it's a dam constructed in Idaho, USA. the first failed during the first filling on June 5th, 1976. The water level was about one meter below the spillway weir crest. There was no sign of malfunction until the sediment-laden leak was seen flowing from the right abutment, Figure 4. The leakage and erosion accelerated until the dam had failed, as shown in Figures (5 and 7). The dam has not been rebuilt and its remains can still be seen at the site.

**Figure 5.** Photograph of Teton Dam: approaching mid-day, the leak has enlarged further and widened under crest, [7].

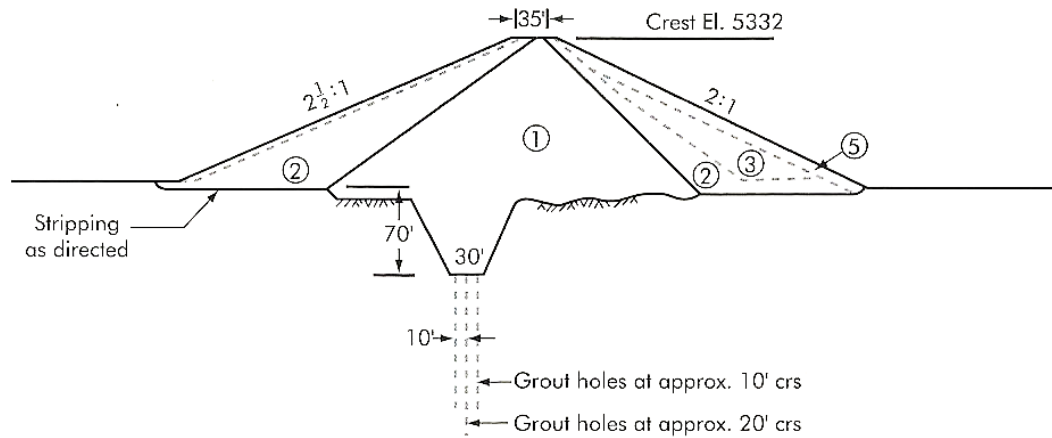
Following practice at the time, no filters were provided to prevent erosion in the windblown non-plastic to slightly plastic Zone 1 core fill. The means provided to stop erosion were grouting of the foundation from a grout cap under the core in a cut-off trench through the alluvium in the floor of the valley and in key trenches in the upper parts of the core contact zone (above El 5,100-ft).

**Figure 6.** Schematic diagram of the Teton Dam: Section with a deep cut-off trench at failure position in right abutment, [6].

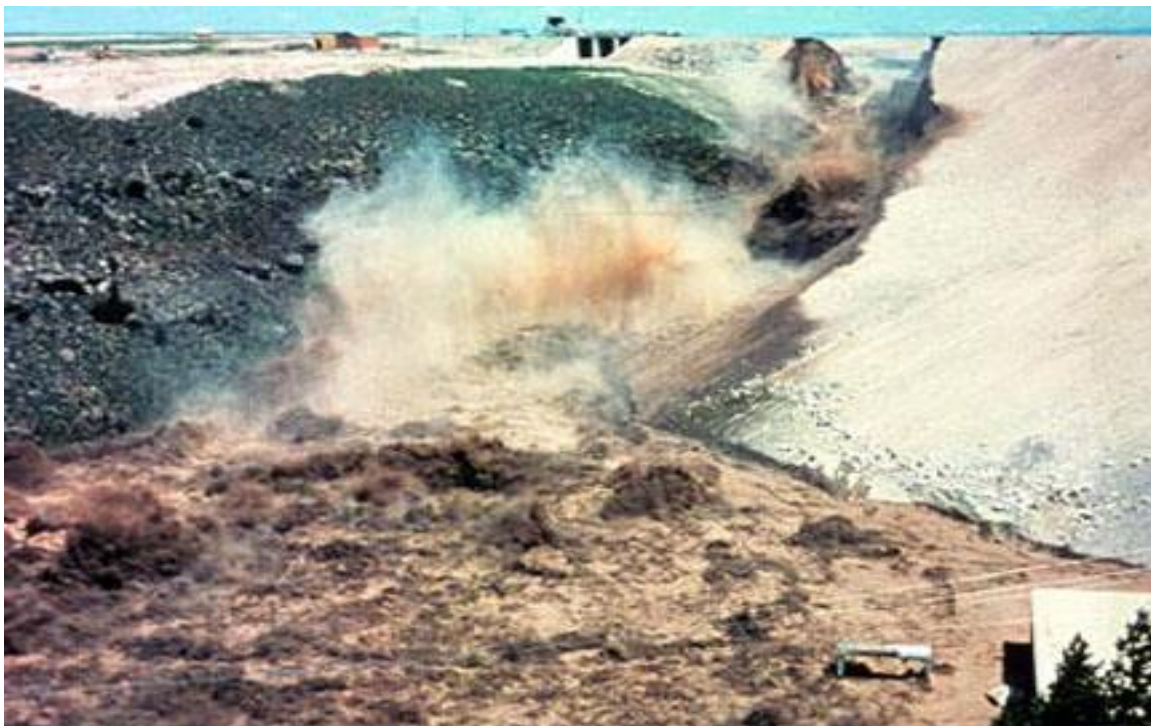
**Figure 7.** Photograph of Teton Dam: leak has enlarged and widened, crest (bridge) has collapsed, the outflow exceeds 28,300 m<sup>3</sup>/s eroded all the dam fill entirely, [7].

Mr. Chadwick's review the cause the Teton Dam failure and summarized that the failure at Teton followed what is now recognized as the four phases of internal erosion leading to failure, as follows:

- **Initiation:** in this case by erosion in concentrated leaks through the Zone 1 fill in the right abutment key trench at approximately the location is shown in Figure 8. The cracks and openings probably formed by one or both of the following: from below by water flowing through open joints in the trench foundation not sealed by dental concrete, slush grouting or the grout cap and grout curtain; and through hydraulic fractures resulting from low total stresses caused by 'arching' in the deep steep-sided key trench and possibly from unfavorable

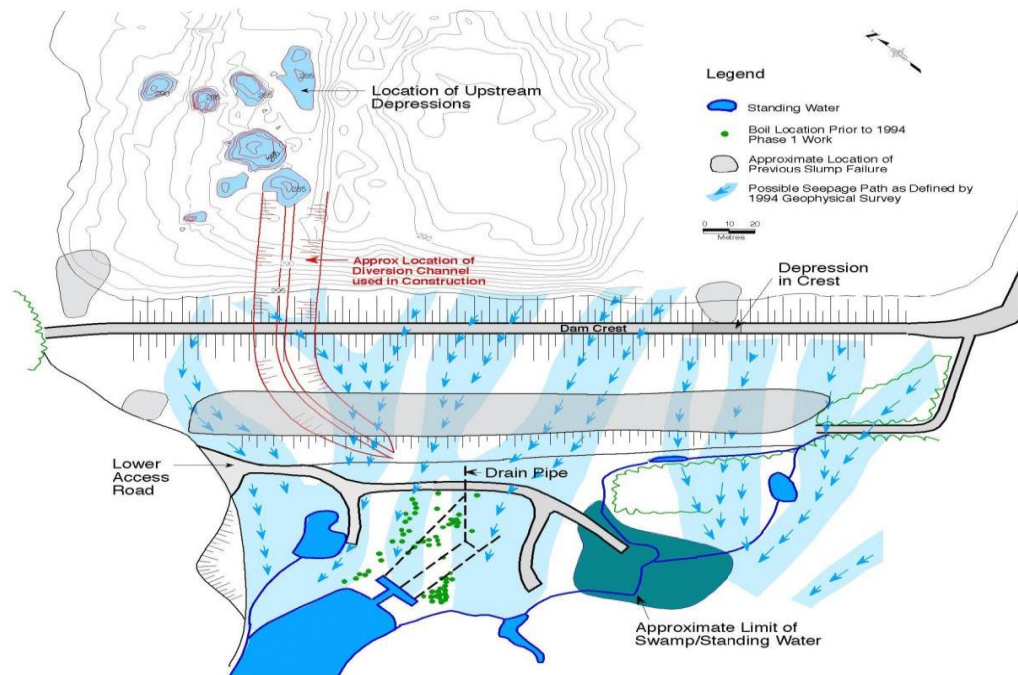
During impounding in 1958 numerous seepage incidents occurred with leakage up to  $1.0 \text{ m}^3/\text{s}$  and local instability on the downstream slope. Toe berms and additional blankets were added, and the dam performed satisfactorily for about ten years. Then downstream sand boils, piping incidents and sinkholes re-commenced, including one sinkhole which in 1971 opened up at the toe of the upstream slope, causing a slope failure, which fortunately did not break through the dam crest. A record of this event (which after repair left a depression in the crest) and the many sinkholes, seepage routes, sand boils and other damage which occurred is shown in Figures 10 and 11.

**Figure 10,**Shikwamkwa Dam: a record of upstream sinkholes, erosion pipe routes, downstream sand boils and the depression left in the crest after slope failure caused by sinkhole opening up at upstream toe , [10]

The upstream blanket may have been thin and may have cracked as settlement across the old river channel occurred, but the downstream sand boils, the piping and the upstream depressions, confirm that what is now known as backward erosion was occurring. It does not appear to be forward erosion through concentrated leaks, cracks and openings, in the blanket and foundation.

The upstream blankets can be ineffective in reducing the overall hydraulic gradient that initiates backward erosion, almost certainly in this case because the blanket materials were fine and vulnerable to backward erosion from below.

At Shikwamkwa, the emerging upstream end of one of the erosion pipes was at the upstream toe of the dam, causing instability of the slope, but fortunately not cutting through the crest, thereby narrowly avoiding failure by overtopping.

Repairs were conducted to allow the life of the dam to be extended. The repairs program included a downstream filter blanket and a fully automated monitoring system consisting of piezometers, weirs and a turbidity meter.

Upstream blanket materials should be plastic or sands and gravels too coarse to be vulnerable to backward erosion from below.

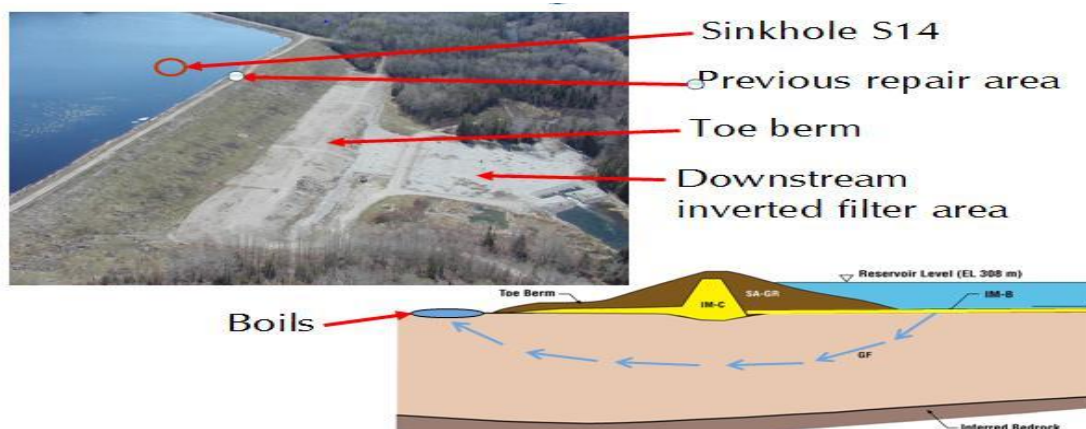
**Figure 11.** Shikwamkwa Dam: showing damage, filtered toe berm and section of erosion pipes [10]

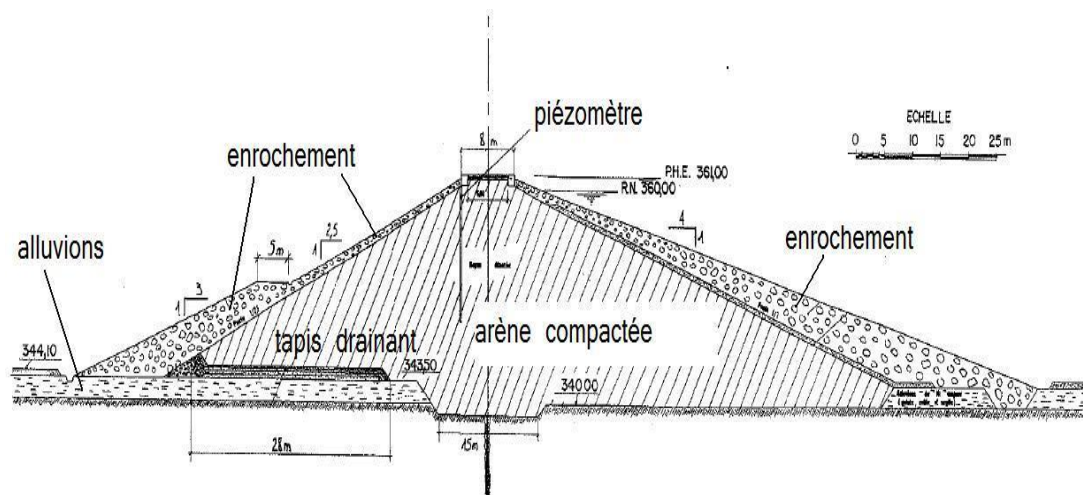
**Figure 13.** Saint Pardoux dam: decomposed granite fill with coarser material on the upstream and downstream slopes, and a horizontal downstream drain.

The dam was completed, and the reservoir filled in 1976. An expert assessment in 1991 found high and increasing pore pressures in the downstream slope, wet areas on the slope and leakage emerging on to the slope and at the abutments. There was also an increase in the seepage collected from below the upstream slope.

The progression of piping could be taken to mean gradual loss of fines and increase of seepage, indicates that suffusion was occurring in the fill and that there was preferential drainage through some sandy layers included in the fill.

To correct the situation, a diaphragm wall was installed from the crest, the foundation grout curtain was made deeper and wider and drainage added, and other works were completed in the abutments. [6]
