# DOCTORAL THESIS

## Seismic rehabilitation of historical heritage built -SUMMARY-

Eng. Daniel-Ioan DIMA

BUCHAREST  
November 2021

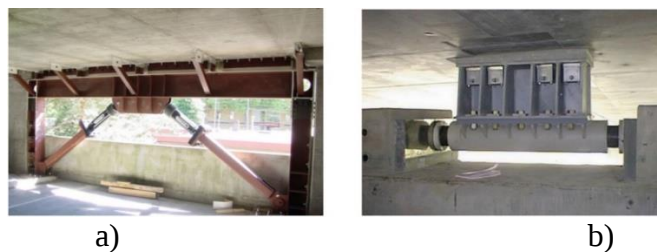
Figură 5.19 - Amortizori vâscoși în diverse sisteme de atenuare a energiei seismice [98]

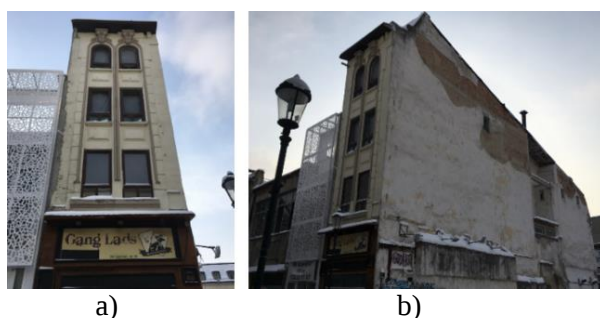
The building (Figure 6.4) was built around 1930, has the destination of "house" and is included in the List of Historical Monuments in Romania, being registered with the code B-II-B-19041 [119]. At the time of the study, there was no technical construction book and no history of its design, execution and operation, but, as it was found, from a structural point of view, it has a mixed composition.

Figure 6.4 - a) Main facade; b) Side facade [119]

The main objective of this case study is to evaluate the dynamic response of the structure of an existing building, located in the old center of Bucharest, Str. Lipscani no. 66, having height regime Sp + P + 2E + M, with overall dimensions in plan of ~ 5x27 m, and atypical, elongated shape (ratio ~ 1: 6).

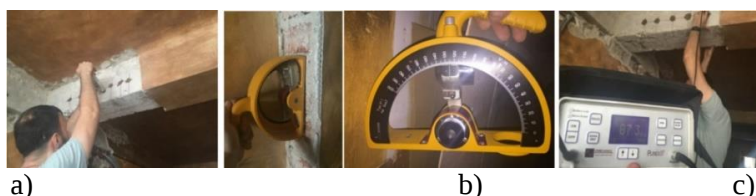
Figure 6.11 - a) Sclerometry method used to determine the compressive strength of reinforced concrete; b) sclerometry method (8x14x28 cm brick masonry elements); c) Ultrasonic method for determining the quality / possible defects of reinforced concrete [119]

The determination of the compressive strength of reinforced concrete was used using the sclerometry method, using a specific device (Figure 6.17a), and the compressive strength of the brick masonry was also determined by the sclerometry method (Figure 6.17b), using a specific device for masonry. Evaluations of the quality of the concrete were also performed, using the ultrasonic method (Figure 6.17c).

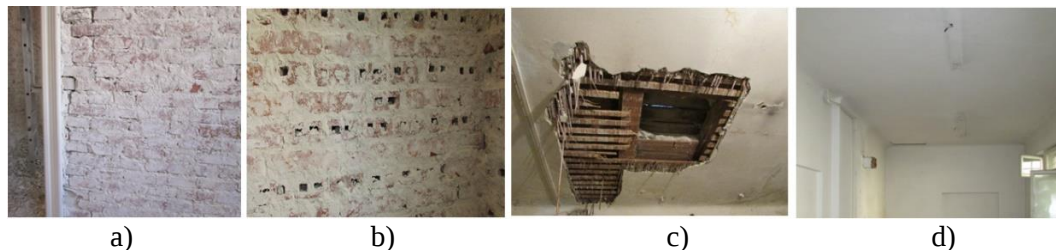
Figure 6.19 - a) load-bearing walls made of pressed solid ceramic brick; b) inserts / completions with masonry made in American style, from ceramic bricks with horizontal gaps; c), d) floor with wooden structure; [122]

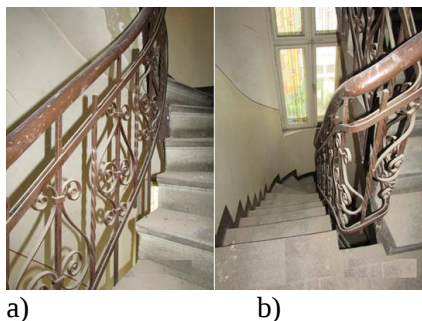
Figure 6.21 - Balanced reinforced concrete staircase, which provides access vertically, over the entire height of the building, including the basement [122]

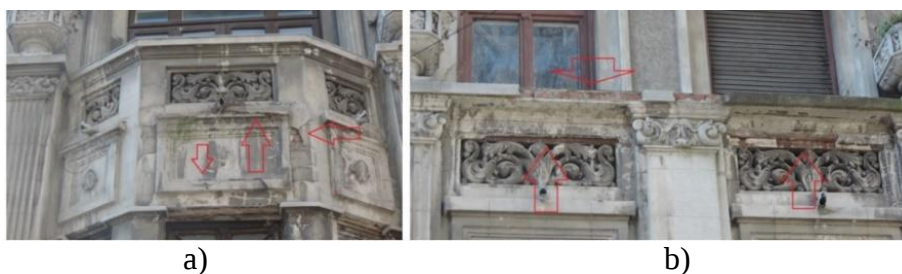
Figure 6.24 - a), b) Degradation of the main facade plasters [122]

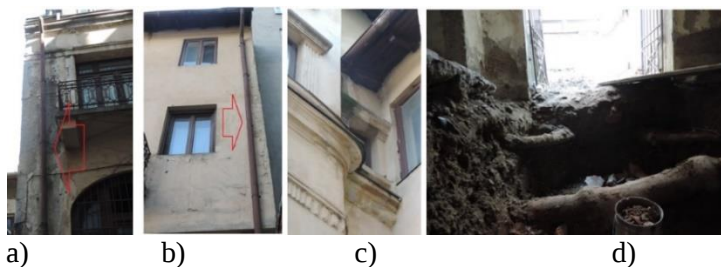
Figure 6.25 - a) Degradation of exterior plasters, caused by damaged rainwater collection and management systems; b), c) Traces of rainwater infiltration; d) Obsolete sewerage installations [122]

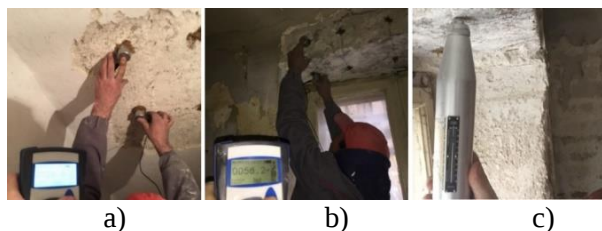
Figure 6.27 - a) Betonoscopie rampă demisol; b) Betonoscopie buiandrug fereastră demisol; c) sclerometrie buiandrug fereastră demisol [122]
