**MINISTRY OF EDUCATION  
TECHNICAL UNIVERSITY OF CONSTRUCTIONS BUCHAREST  
FACULTY OF HYDROTECHNICS**

**SUMMARY  
Ph.D. Thesis**

**RESEARCH ON COMBATING SOIL EROSION THROUGH THE  
ARRANGEMENT OF HYDROGRAPHIC BASINS WITH  
ECOLOGICAL WORKS**

Bucharest 2022

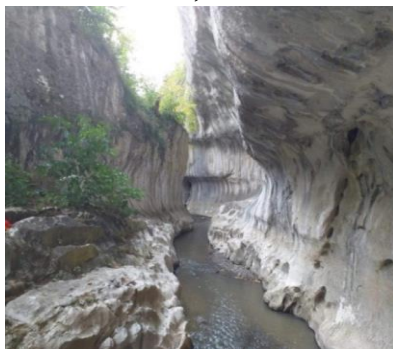
Fig.1.2. Linear erosion,  
Bănița brook

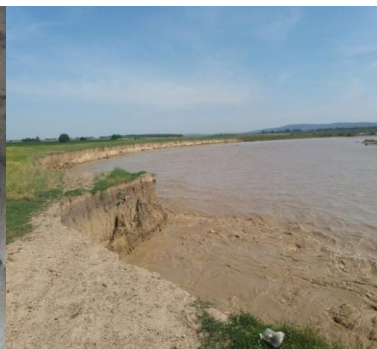
Fig.1.3. Lateral erosion,  
Putna river

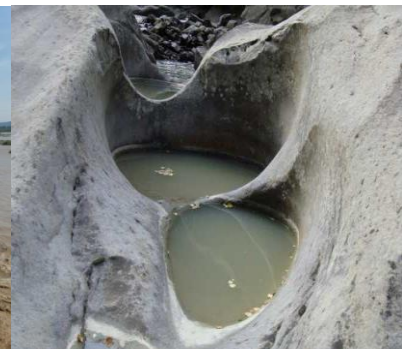
Fig.1.4. Karst erosion,  
Zăbala river

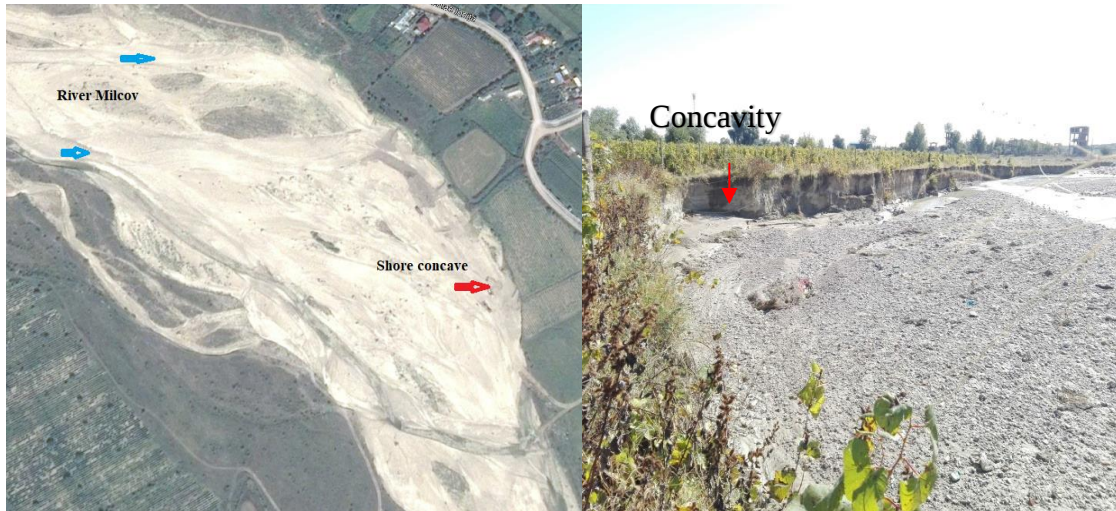
Figure 3.1 shows the area with concavity on the map generated by Google Earth and the appearance of the erosion studied.

Fig.3.1. Aspect of left bank erosion, Milcov river, loc. Odobești, Vrancea County

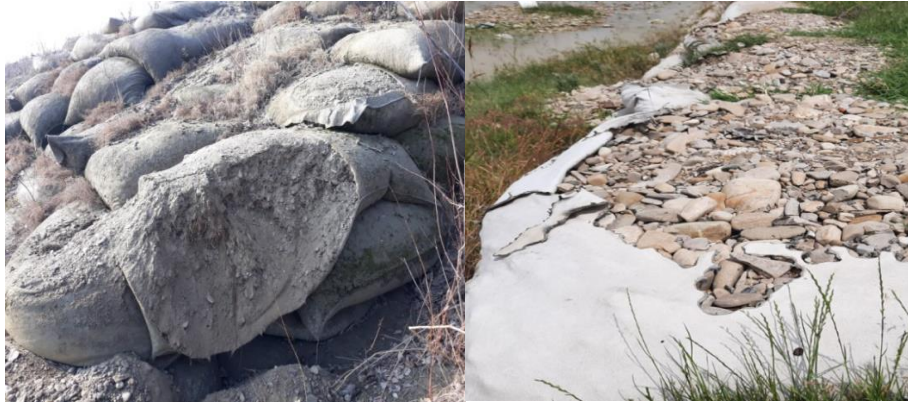
Vandalism is an action that involves the intentional destruction or damage to property.

- Cutting the bags;
- Arson.

Fig.7.4. Degradarea prin vandalism, tăierea sacilor și incendiere

In order to avoid the degradation of the geotextile by UV rays, it is indicated to cover the geocontainers with vegetal soil, this allows the development of the plants, but also avoids degradation of the work by vandalism.

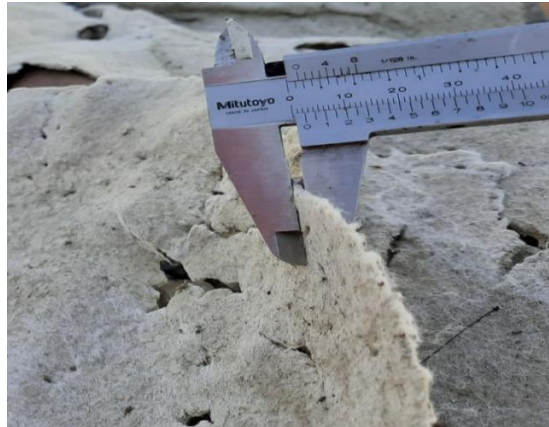
Figure 7.5 shows that the geotextile after a lifetime of about 8-10 years, under climatic conditions and sediment transport, is affected, and its thickness has decreased to about 0.3

cm. It is vulnerable or even destroyed by, where the phenomenon of degradation or damage to the work in geocontainers also appears.

Fig.7.5. Geotextile degraded by U.V. and alluvium transport

In order to evaluate the behavior of the geotextile used in the manufacture of geocontainers over time, the measurement of different geotextile samples was performed. The first measurement was made on a sample of geotextile not used in the works, which has a thickness between 0.5 and 0.6 cm. It has a lifespan of about 8-10 years, in variable climatic conditions and sediment transport is affected, and its thickness has decreased to about 0.3 cm and is vulnerable or even destroyed, hence the phenomenon of degradation or damage of of the work.

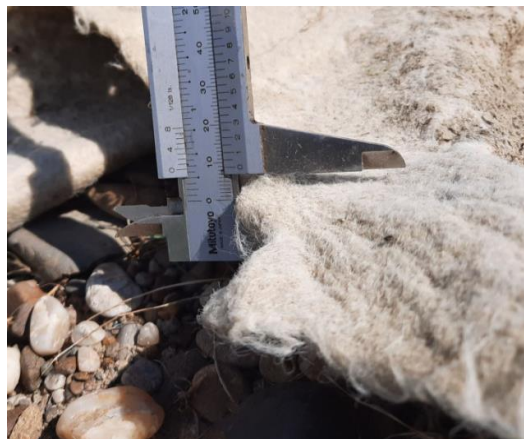
Floaters transported by the river affect the work in geocontainers by breaking the geocontainers or reducing the density of the geotextile where the phenomenon of migration or washing off sand from the geocontainers can occur, which can lead to damage to the work in the geocontainers.

Figure 7.6 shows that the geotextile loses its density, is fluffy, and increases its thickness from 0.5-0.6 cm to 0.7-0.8 cm, which leads to the weakening of the fabric and helps to wash sand.

Fig.7.6. Geotextil afectat de plutitori

Another measurement was made on a sample of geotextile that was degraded by floats that are transported by the river during floods, where it shows that the geotextile loses its density, is fluffy and increases its thickness from 0.5-0.6 cm at 0.7-0.8 cm, which leads to loosening of the fabric and helps to wash the sand.

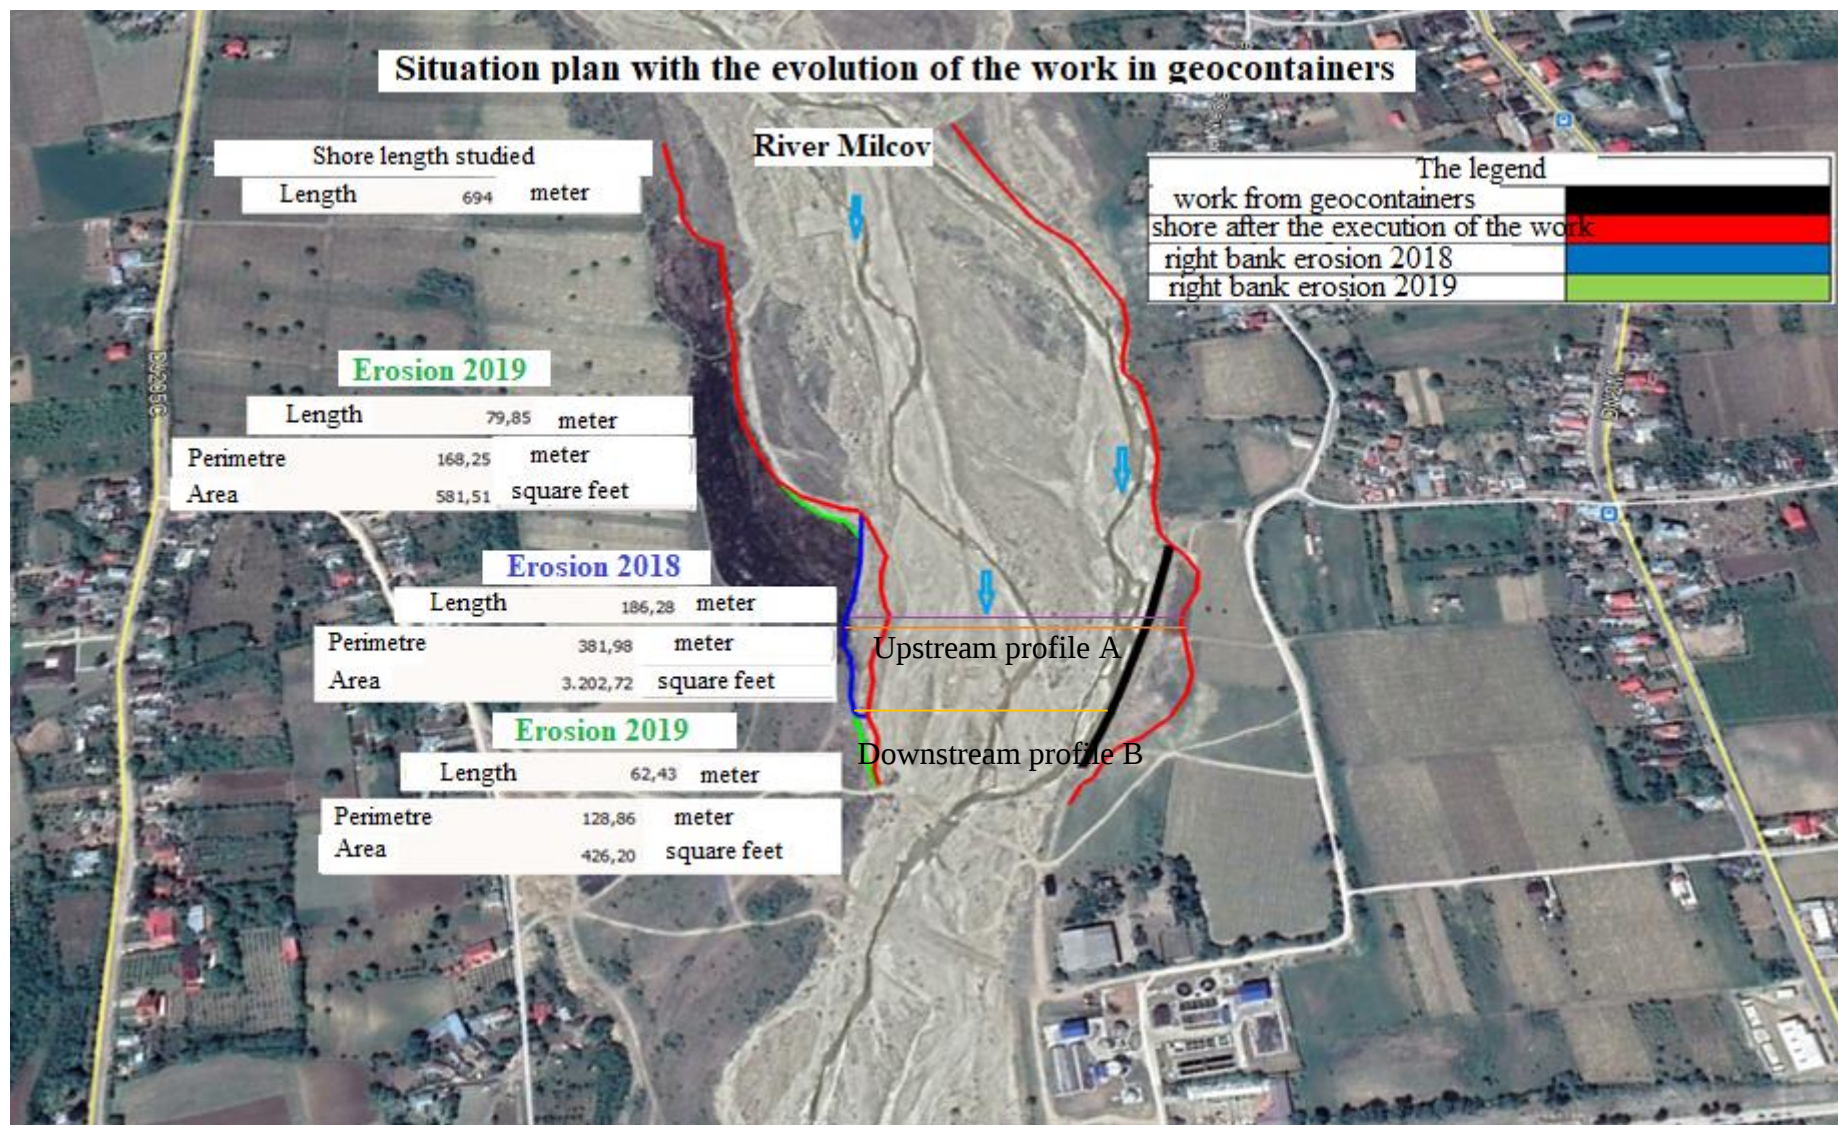
In order to follow the behavior of the Milcov riverbed, we marked with reference points the monitored area to represent the eroded surface and length of the right bank for each year. The map used for representation was generated by Google Earth.

Fig.9.1. Spatial evolution of geocontainer work between 2018 and 2019 (Google Earth map)

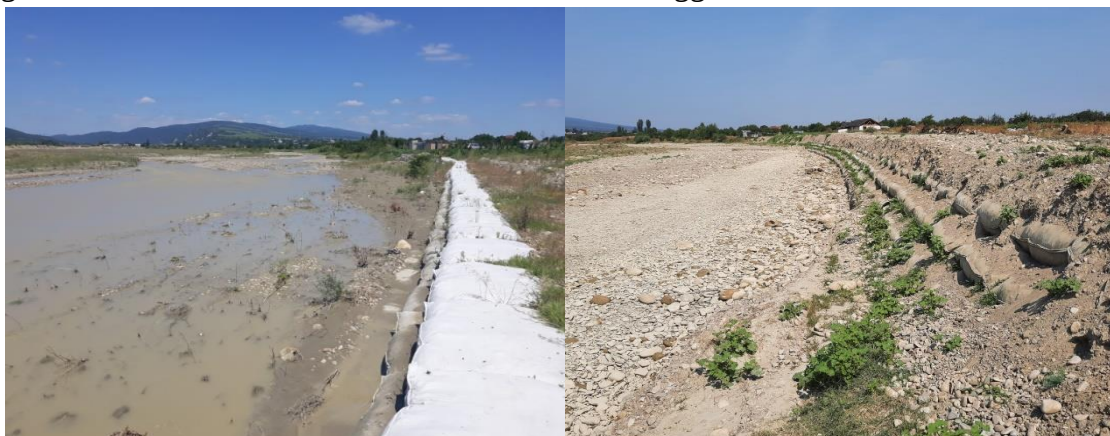
Figure 9.8 shows the evolution of the work and the clogged area.

Fig.9.8. The evolution of alluvium deposits in the work area

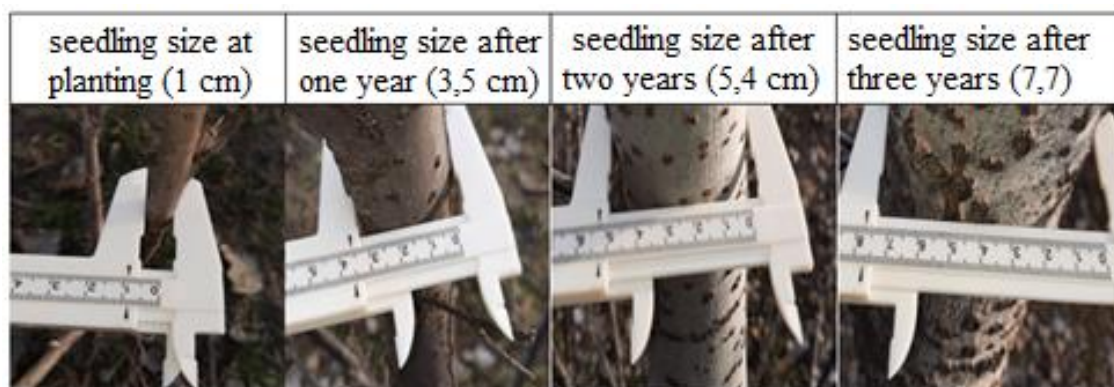
The results of the measurements are presented in figure 9.9.

Fig.9.9. Annual development of poplar seedlings

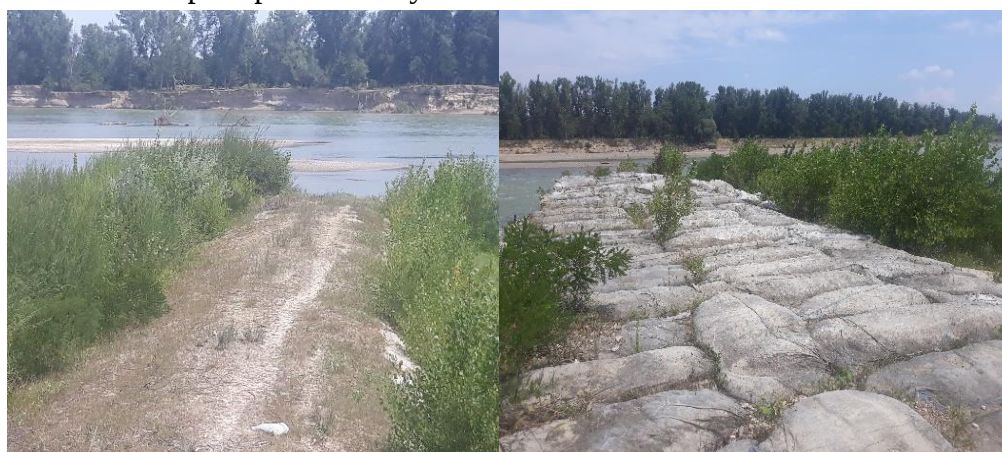
In addition to the aspen seedlings planted, new poplar seedlings from other species also appeared and developed spontaneously.

Fig.9.10. Development of spontaneous plants and shrubs in the areas with geocontainer works

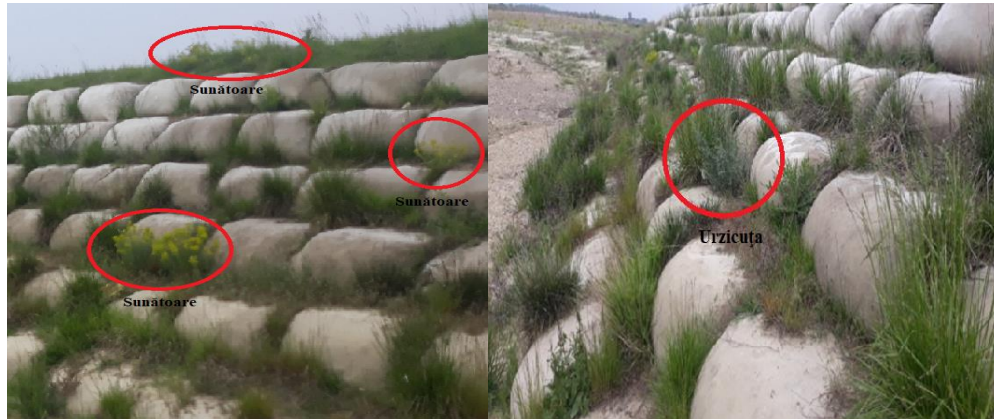
Following the observations made in the field, the presence of sensitive species, naturally occurring such as St. John's wort and nettle, was found on the geocontainer works (figure 9.11).

Fig.9.11. The appearance of sensitive species on geocontainer works

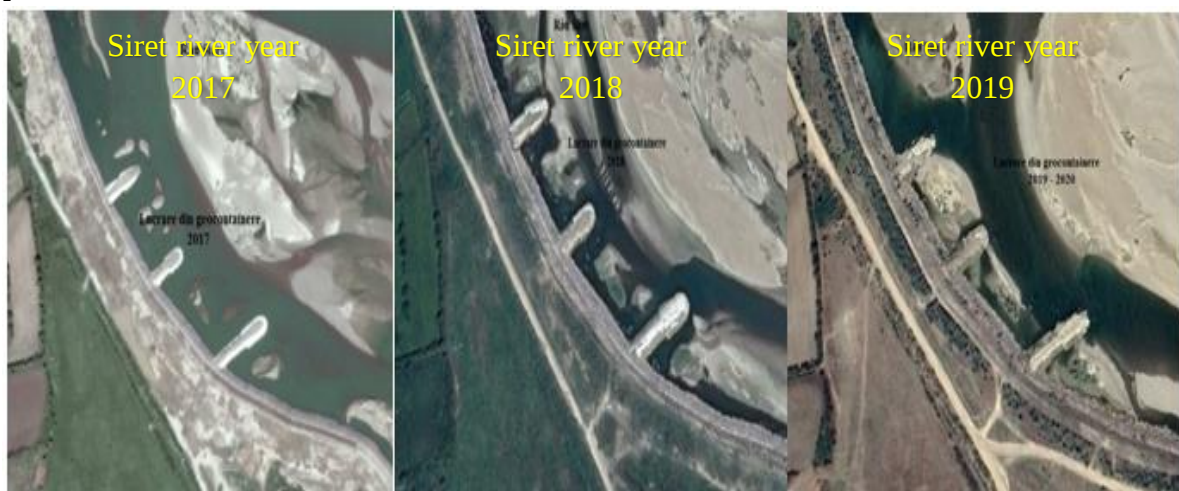
Figure 9.12 shows the evolution of vegetation development on geocontainer works in the period 2017-2020.

Fig.9.12. Vegetation development on geocontainer works
