**Doctoral thesis**  
**The seismic resilience of interwar buildings**

**Scientific report II**

**Original experimental research, carried out through  
European scientific programs, at the turn of the centuries XX  
- XXI**

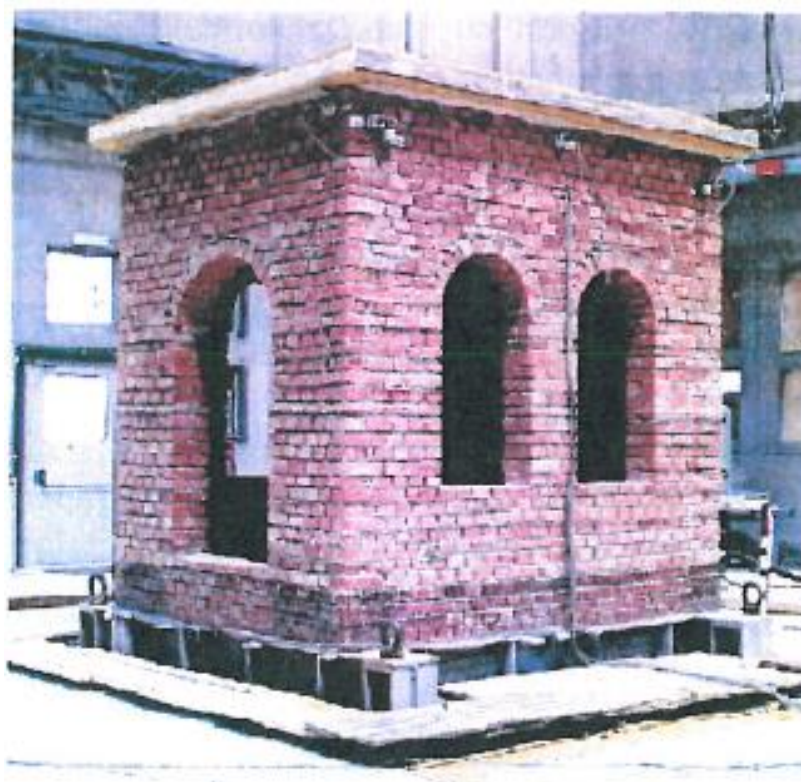
The 3D model of the heritage building was made out of solid brick masonry and lime mortar. The top view dimensions of the model were of 2.78x2.17 m, and the height was of 2.9 m. The thickness of the walls was of 23 cm, and the dimensions of the bricks were of 230x105x60 mm. On two opposite walls, two gaps for windows were made for each wall in a semicircular arch style specific to Brâncuși, having a small pillar between them. A gap for a door was also made with a lintel, in the same semicircular arch fashion. The weight of the model was of 7.2t, while the metallic frame also had 2 t. [4]

Fig. 3.2.1. The 3D model for the solid brick masonry [4]

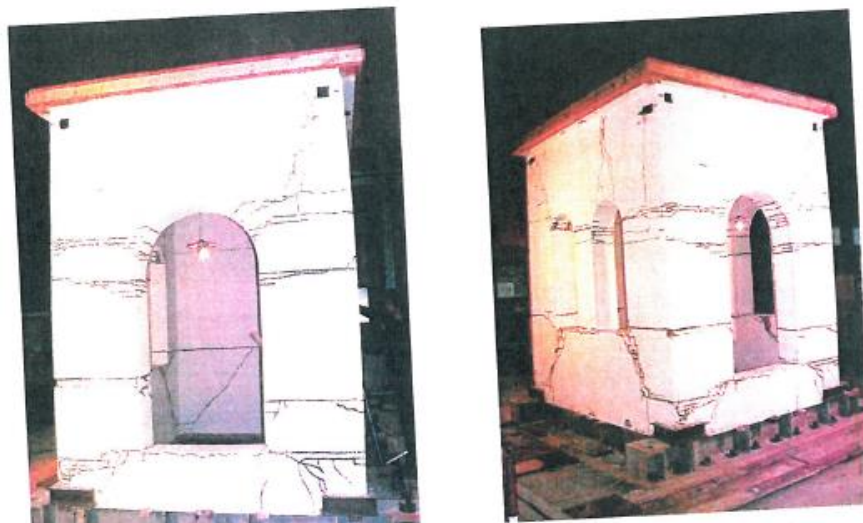
Fig. 3.3.2. The solid masonry with lime mortar model – consolidated [4]

The consolidated model was also subjected to excitations based on the 1977 Vrancea registration, which involved two degrees of freedom. The intensity of the movements was higher, the test stopping when the final state limit was reached. Unlike the first test, on the unconfined model, the final state limit in this case was represented by stability on the seismic mass. The model began to jump off the seismic mass, however it was able to retain its structural integrity.

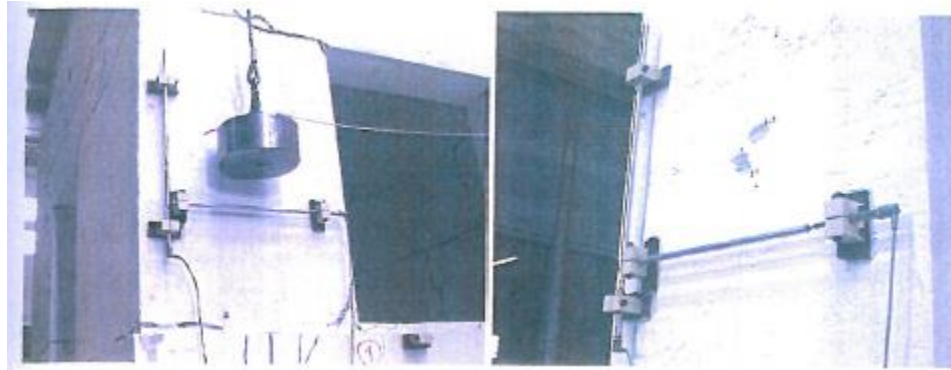
Fig. 6.1.2. The second contact point on the coating of the wall in an area without cracks [23]

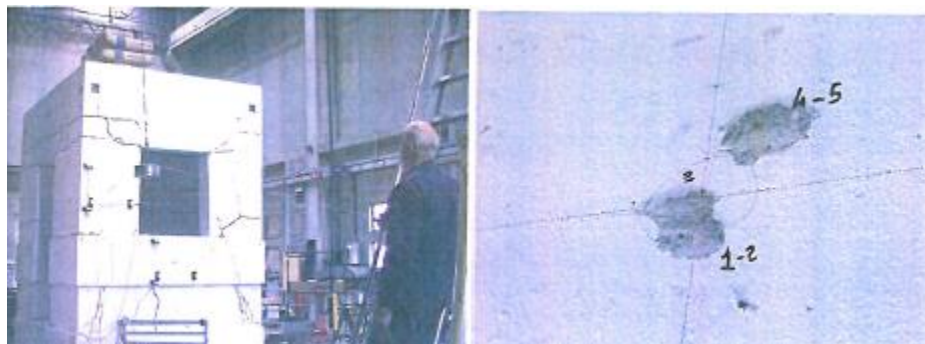
At the first point, the mortar was detached after each impact to depths between 0.8 – 1.8 mm. For the second one, the mortar was detached to depths between 4.1 – 5.9 mm.

Fig. 6.2.2. The footprint of the 5 shocks within the second contact point [23]
