**RESEARCH REPORT NO. 1**

**RESISTANCE OF UNDERGROUND AND BURIED HYDRO-TECHNICAL  
CONSTRUCTIONS IN CASE OF EARTHQUAKE**

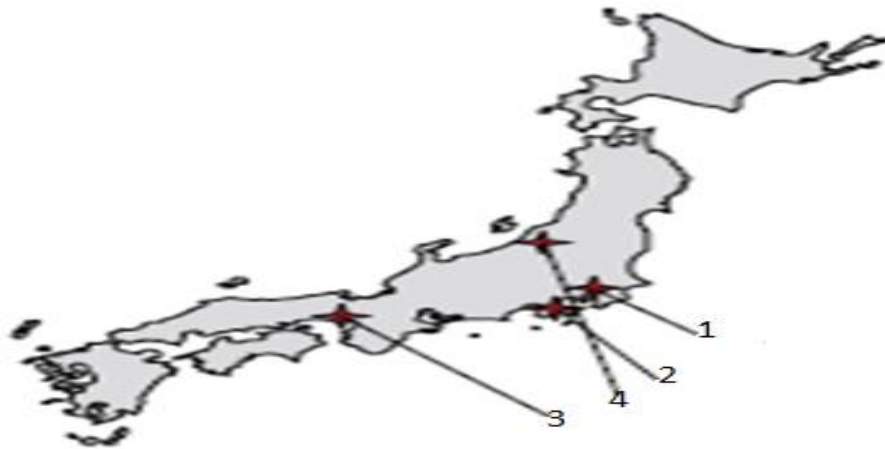
Fig. 3.2. Areas affected by the four earthquakes.  
1,2,3,4- corresponds to item no. from table 1.

In Japan, four major earthquakes were felt by the underground works: the Kanto earthquake (1923), the Izu-Oshima-Kinkai earthquake (1978), the Hyogoken-Nanbu earthquake (1995) and the Niigataken-Chuetsu earthquake 2004. The damage caused by these earthquakes is shown in table 1. and in Fig. 3.2. a sketch with the area affected by the four earthquakes is shown.

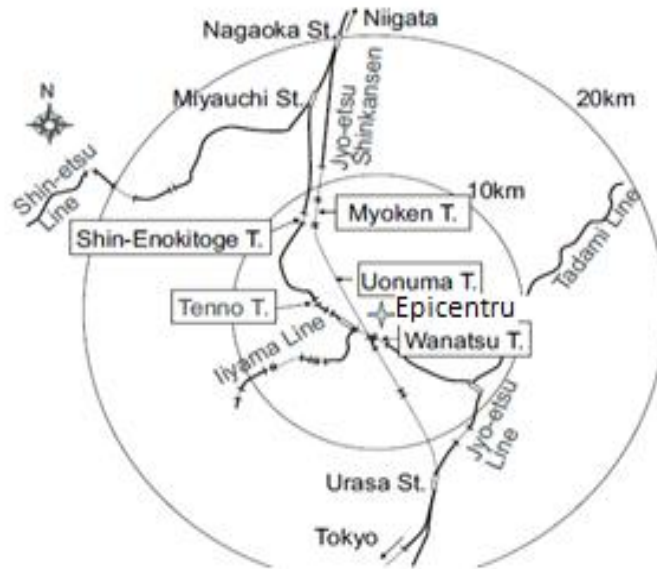
Fig.3.11. Distribution of severely damaged tunnels upon the Niigataken-Chuetsu earthquake.

The earthquake caused the derailment of a train on a line in the Shinkansen system, and several mountain tunnels suffered serious damage. Twenty-four tunnels have been damaged and five of them (Unuma, Myoken, Wanasu, Tenno and Shin-Enokitoge) require consolidation.

Figure 3.11 shows the distribution of severely damaged tunnels during the earthquake, and Figure 3.12 shows the number of damaged tunnels.

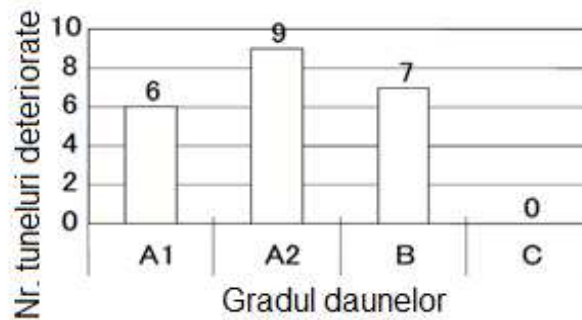
Fig.3.12 Number of damaged tunnels and degree of damage.

A1-major damage requiring repairs and consolidations, A2 damage requiring repairs, B-damage that does not require repair, C-no damage.

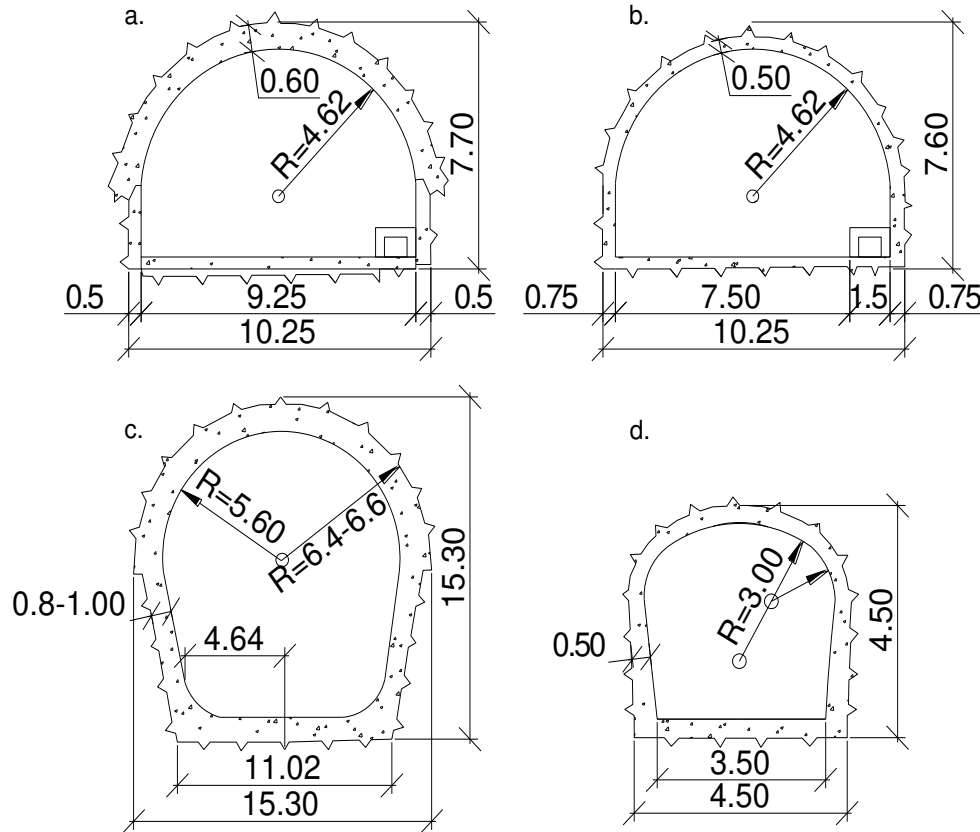
Fig.3.19.Types of UHCirkeisk lined sections:

The constructive composition of tunnel sections and escape galleries is shown in Figure 3.19. They are lined with plain or reinforced monolithic concrete. The car tunnel, which passes through an area with large tectonic abnormalities, was used during the construction of metallic reinforcement. At the time of the earthquake, the Sulac River was deflected through the diversion

In an area of the tunnel, located at approx. 300 m of exit, there occurred faults with openings up to 12 mm, between the walls and the basin at the base of the tunnel (fig.3.19.a), and in the vault a zigzag fault system with openings up to 5 mm. There were no tectonic cracks in this area, but there was a stratigraphic boundary of some rocks with a coefficient of strength (according to Protodiakonov) from 4 to 7. It is believed that an essential role in the formation of longitudinal cracks at the wall-to-tack contact had the foundation's inhomogeneity and the local discontinuity of the structure.

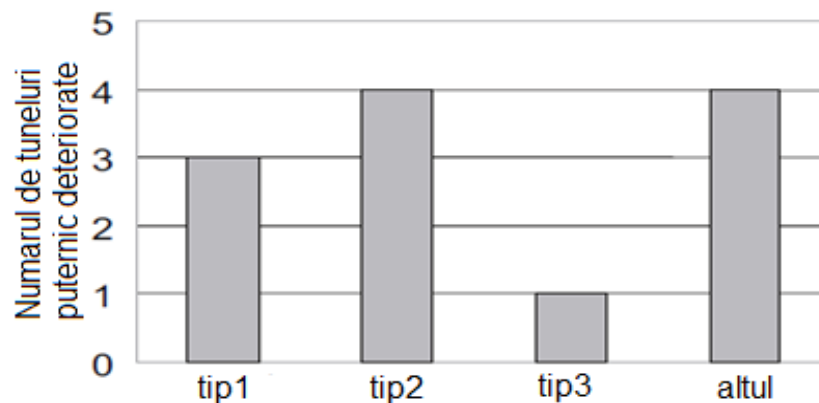
Fig.4.1 Number of damaged tunnels by type of damage.

Figures 4.1.4.2 show the classification of damage types after the following earthquakes: Izu-Oshima-Kinkai (1978), Hyogoken-Nanbu (1995) and Niigataken-Chuetsu (2004).

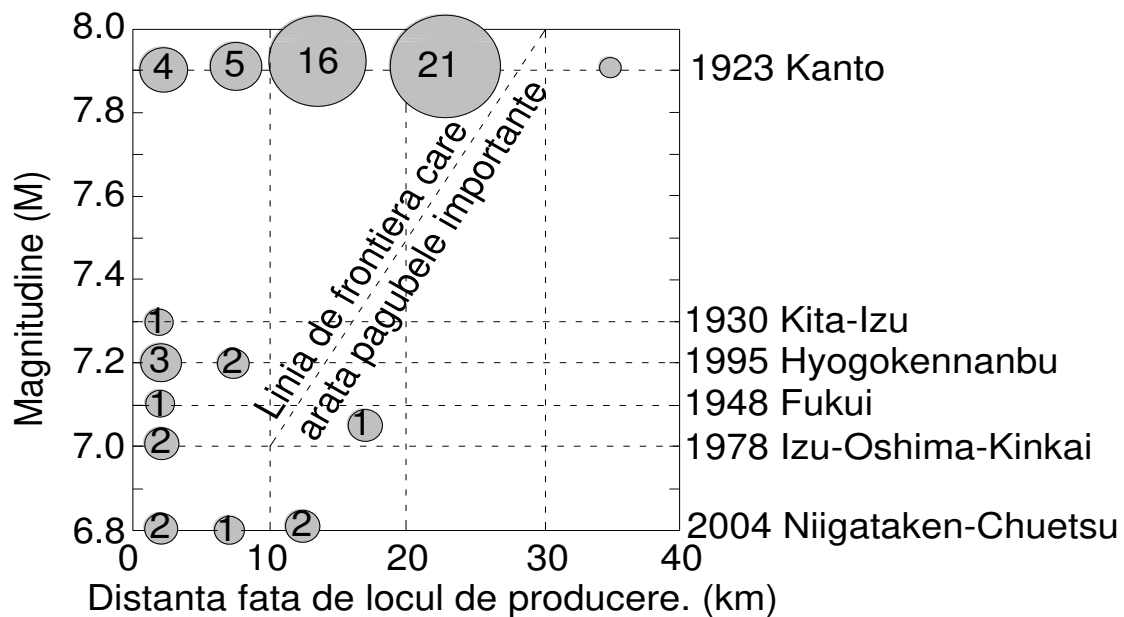
Fig.4.6. Relationship between the magnitude of the earthquake, the distance from the epicenter and the number of severely damaged tunnels.

Fig.4.6 shows the relationship between the magnitude of the earthquake (the most important earthquakes experienced in Japan), the distance to the epicenter and the number of severely damaged tunnels, it is shown that the risk of damage due to an earthquake is quite high in both cases.

The tunnels suffered considerable damage in areas where the distance to the epicenter was about 10 km, and in areas where the distance was between 10 and 30 km, considerable damage only occurred to earthquakes of a very high magnitude.

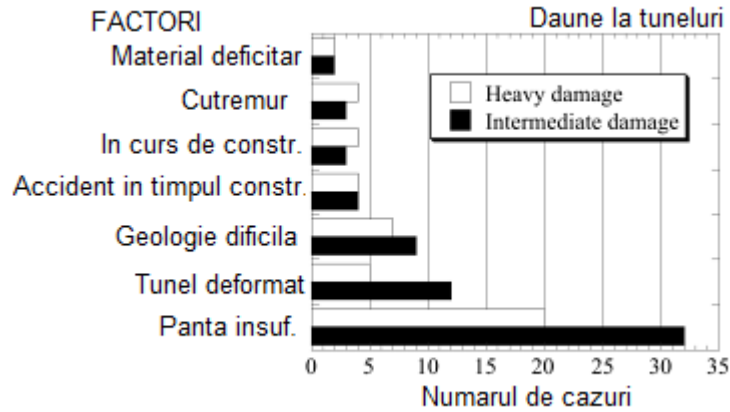
Fig.4.7 Factors related to seismic damage to tunnels

Figure 4.7. is a synthesis of earthquake-induced problems in tunnels. The number of events related to seven different situations is illustrated herein. It is noteworthy that the main problems were caused by the instability of the massive slope above the portal.
