## Research report No. 2

### THE HISTORICAL MAJOR EARTHQUAKES FROM ROMANIA AND THEIR CONSEQUENCES ON BUILT ENVIRONMENT

Eng. Daniel-Ioan DIMA

June 2014

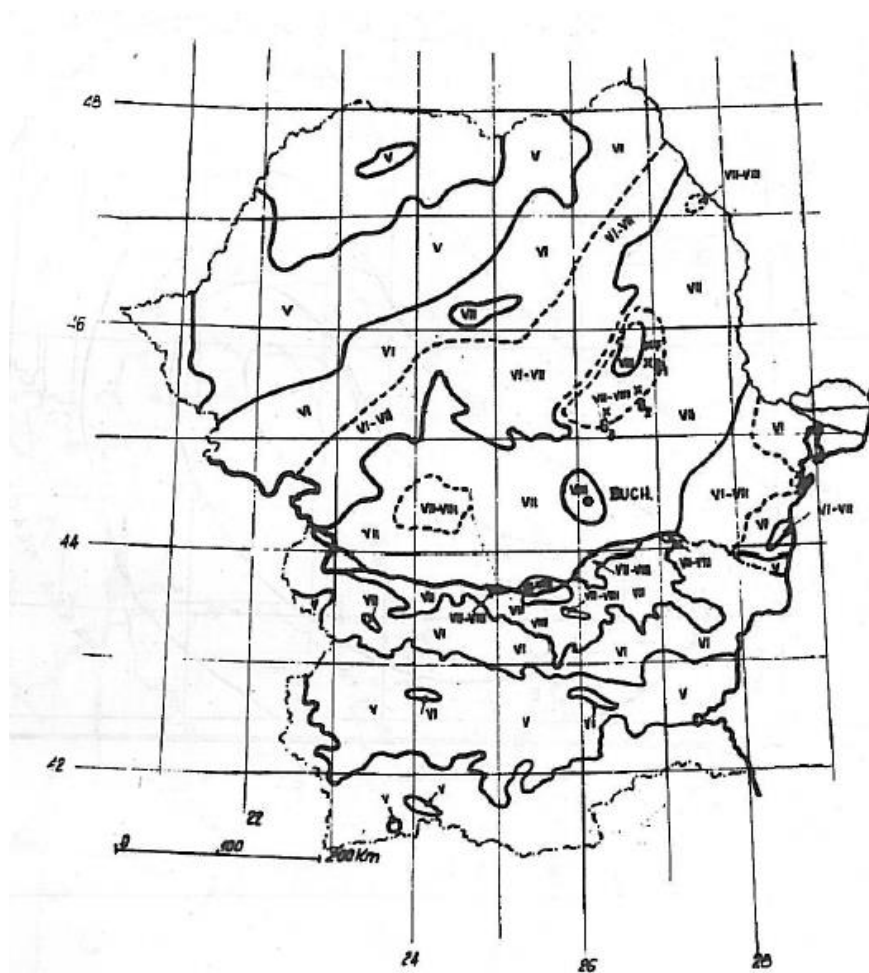
Figure 4 - Isoseismic map of the 1977 earthquake, Romania - Bulgaria [1]

On this map, of seismic intensities, there were at that time, a series of reservations from specialists in seismic engineering, in the sense that it showed an obvious tendency to underestimate the effects of the 1977 earthquake. presented in STAS 3687 - 71, for the evaluation of the seismic intensity according to the MSK - 64 scale, referred to the damages suffered by the rigid constructions, leading to intensities VI... VIII for Bucharest, and for the flexible ones, the intensities increased to VIII - IX and the fact that the level of anti-seismic insurance achieved for many constructions that entered the investigation was not taken into account, as a result of the application of the design norms in force in the period prior to the earthquake. This reservation was also supported by the Soviet seismologist S.V. Medvedev through the map with the isoseists of the 1977 earthquake proposed by him, Figure 4 [1], above.

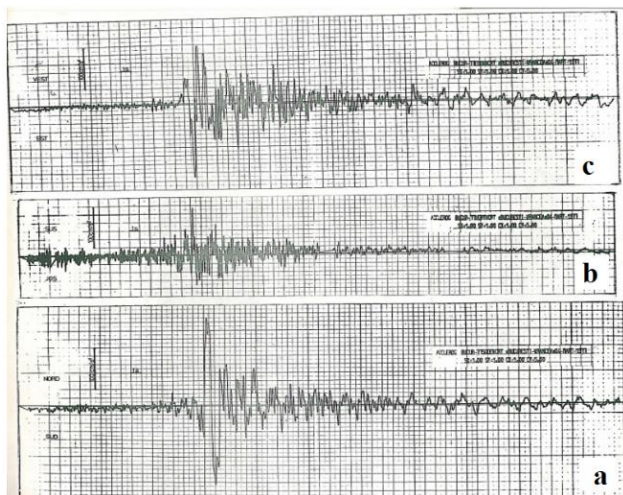
Figure 9 - Accelerogram of registration No. 1 - INCERC - Bucharest, Street Pantelimon 266;

- **recording 1** (Figure 9): INCERC - Bucharest, Street Pantelimon, No. 266, performed with a SMAC-B accelerograph, in the basement of a ground floor building, light, this representing the most important record, can be considered, practically, as a record of the undisturbed movement of the ground and characterized by weak oscillations, predominantly vertical, with a duration of approx. 18 s, strong oscillations, predominantly horizontal, lasting approx. 15 ÷ 20 s, with destructive effects and oscillations being attenuated, with a duration of approx. 40 ÷ 50 s;

the maximum horizontal acceleration, in the most unfavorable direction, exceeded  $2.5 \text{ m/s}^2$ , corresponding to the degree of seismic intensity IX - MSK-64 (STAS 3684-71); also, for horizontal accelerations, long periods of approx. 1 s on the E-V direction, and on the N-S direction, 1.5 s;

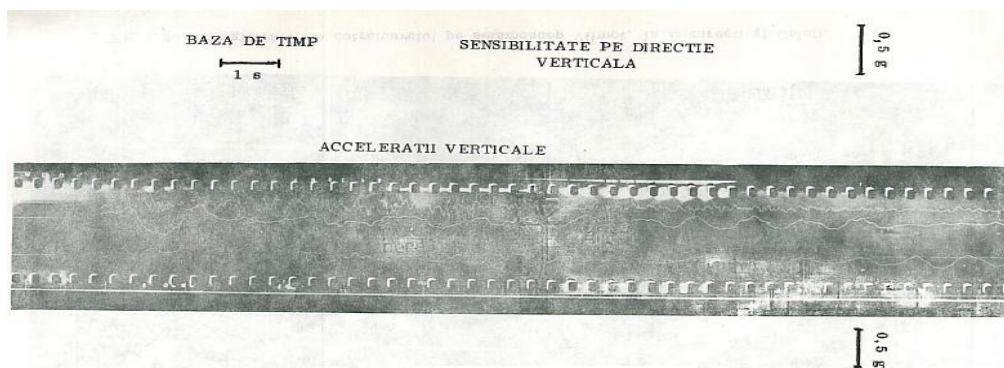
Figure 10 - Recording accelerogram No. 2, Bl. E5 - Balta Albă, Bucharest [10]

- **recording 2** (Figure 10): Block E.5 - Balta Alba in Bucharest (a high and relatively rigid construction), provided by the MO-2 accelerograph mounted on the 9<sup>th</sup> floor and characterized by horizontal acceleration values of approx.  $3 \div 3.5 \text{ m/s}^2$  and periods of approx.  $0.8 \div 1 \text{ s}$ , values much higher than the conventional ones for the structural calculation;

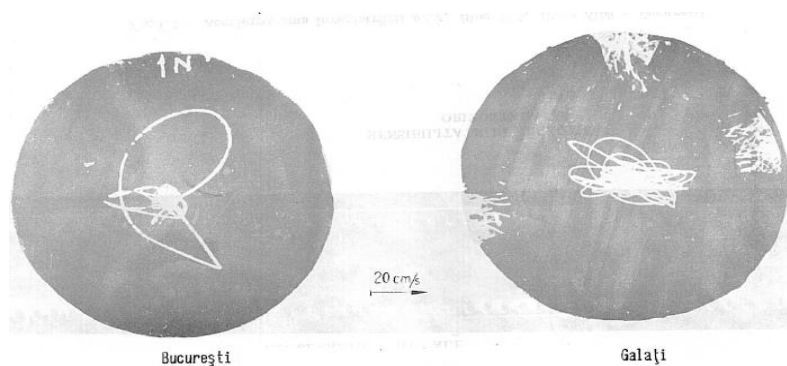
Figure 11 - Accelerograms of records No. 3 and Nr. 4, INCERC, Bucharest and Galați [10]

- **recording 3 and 4** (Figure 11, Figure 12): INCERC - Bucharest, Sos. Pantelimon and Galati, obtained at ground level, with the help of two Wilmot seismoscopes, these highlighting extreme oscillation speeds of approx.  $0.42 \text{ m/s}$  in Bucharest and approx.  $0.27 \text{ m/s}$  in Galati.

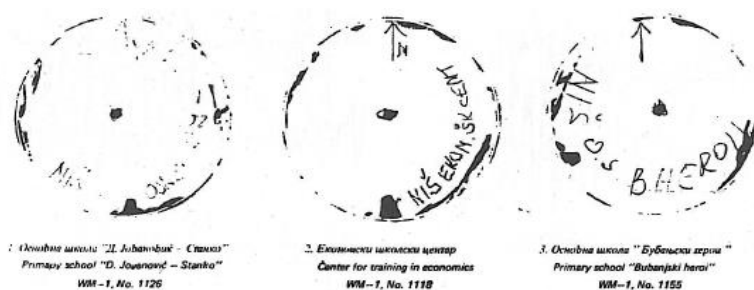
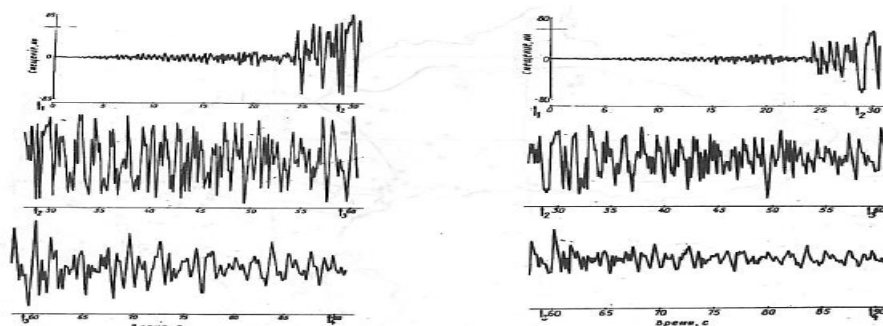
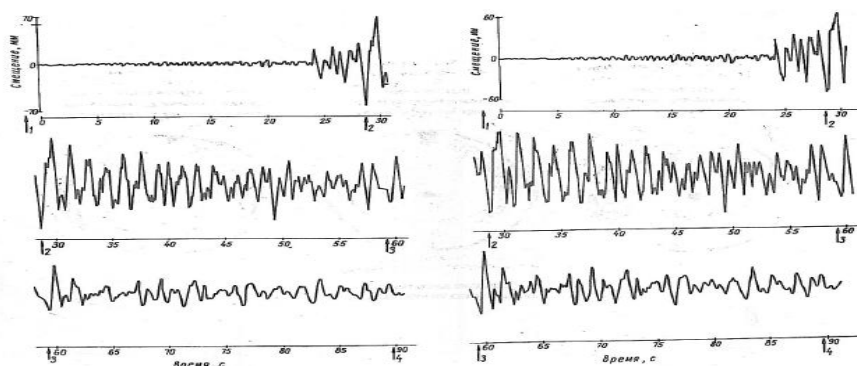
At that time, instrumental seismoscope recordings were obtained from the city of Nis - Yugoslavia and recordings provided by seismographs mounted on the structures of buildings in the city of Chisinau - Republic of Moldova - U.R.S.S. (Figure 22 ÷ Figure 24). These highlighted long predominant periods of movement similar to those in Bucharest, but the peak accelerations had values of approx. 5 times lower, and speeds with values of approx. 8 times lower compared to the values recorded in Bucharest, and in Chisinau, the periods were approx. 1.5 ÷ 1.6 s and maximum ground displacements of the order of 7 cm.
