Universitatea Tehnică de Construcții București

# INCIDENTS IN DAM AND DIKE BEHAVIOR INDUCED BY INTERNAL EROSION

Ph.D. Student  
Al Dulaimi Ali

2019

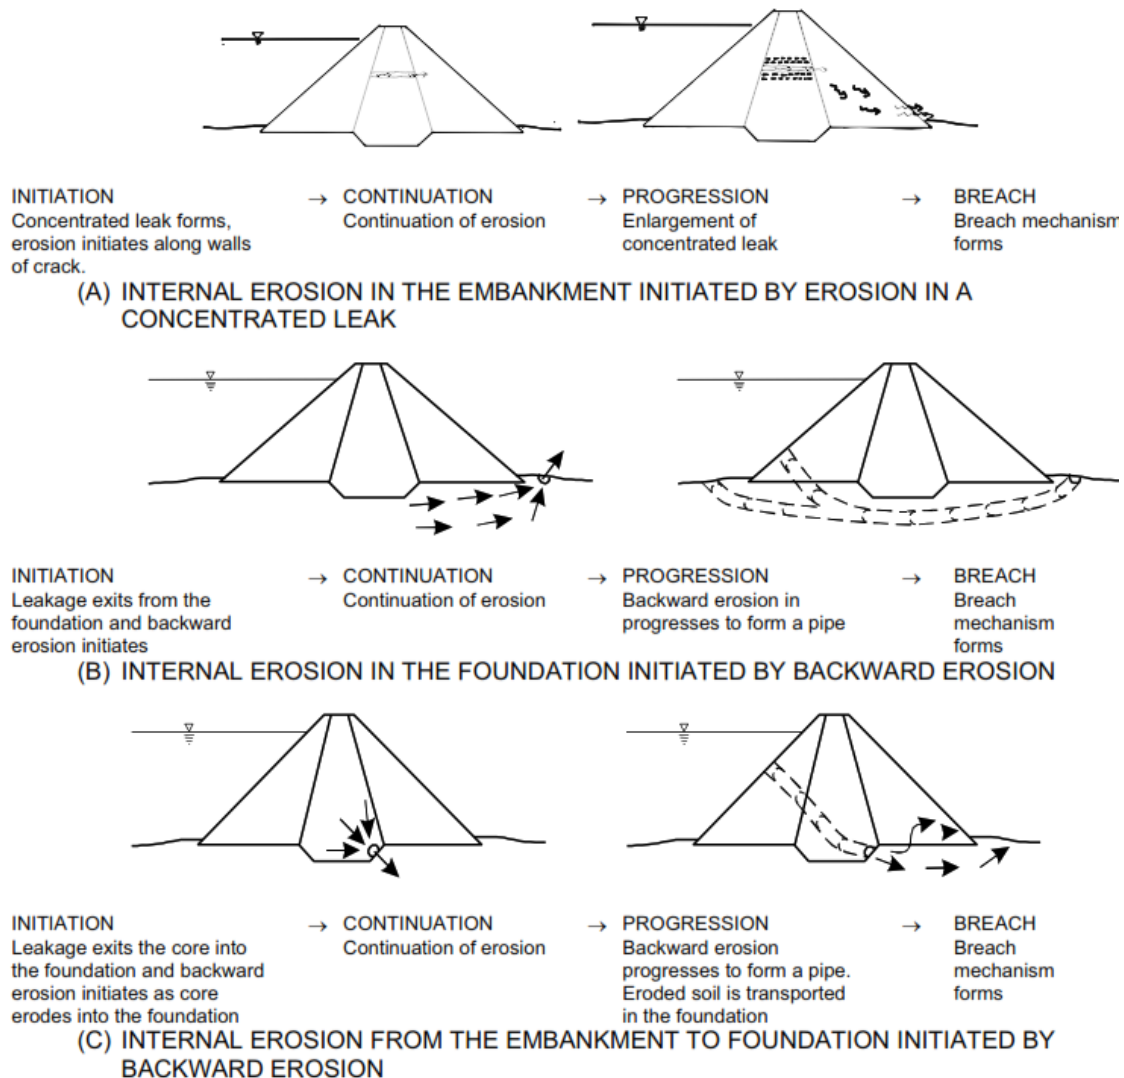
Figure 1(A) shows the internal erosion through the embankment initiated by a concentrated leak. While Figure 1 (B and C) show the similar processes that apply for piping via the foundation, and from the embankment to the foundation.

**Figure 1.** Models for the development of failure by internal erosion, [2].

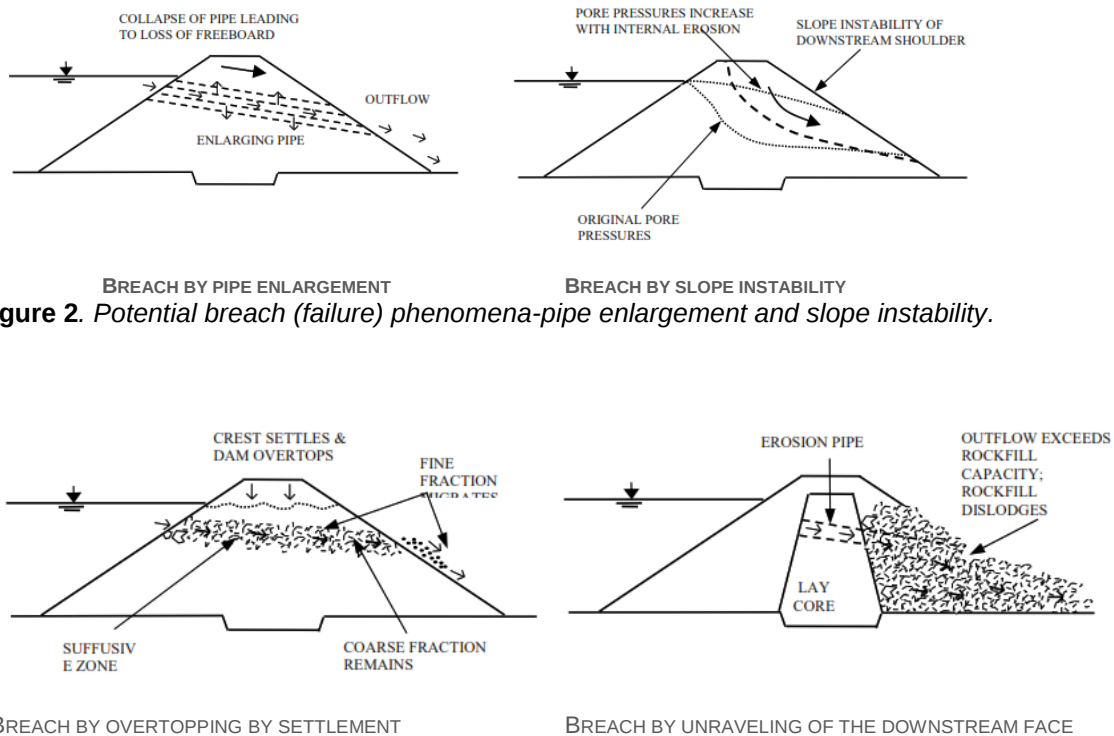
- a. Gross enlargement of the pipe.
- b. Overtopping (e.g. due to the settlement of the crest from suffusion and/or due to the formation of a sinkhole from a pipe in the embankment).
- c. Slope instability of the downstream slope.
- d. Unraveling of the downstream face.
- e. Static liquefaction which is a form of slope instability which may include the increase of pore pressure and sudden collapse in the eroded zone.

**Figure 2.** Potential breach (failure) phenomena-pipe enlargement and slope instability.

**Figure 3.** Potential breach (failure) phenomena-overtopping by settlement and unraveling of the downstream face, [5].

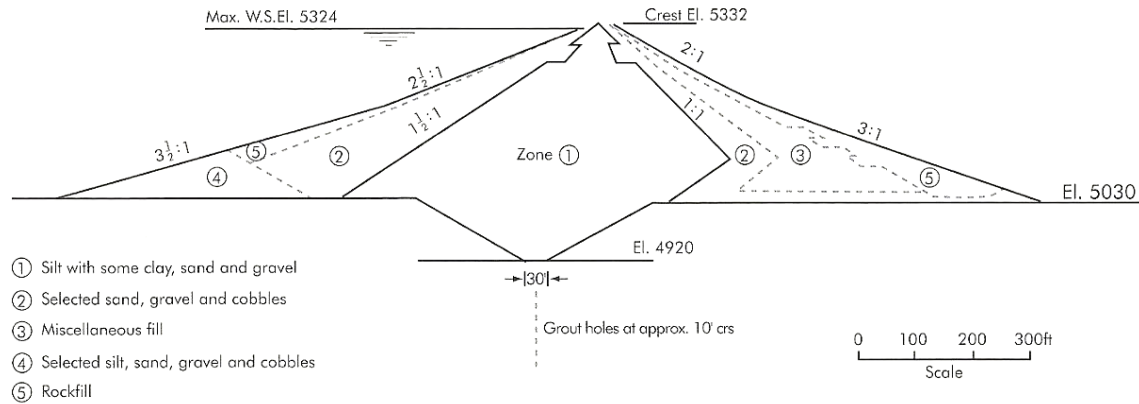
The dam has a 93 m high earth zoned embankment. Sections are shown in Figure 4 in the valley floor and in Figure 6 in the right abutment, around the location where the leakage was first seen, and the failure commenced. [6]

**Figure 4.** Schematic diagram of the Teton Dam: Section in valley bottom showing fill zones and cut-off through alluvium, [6].

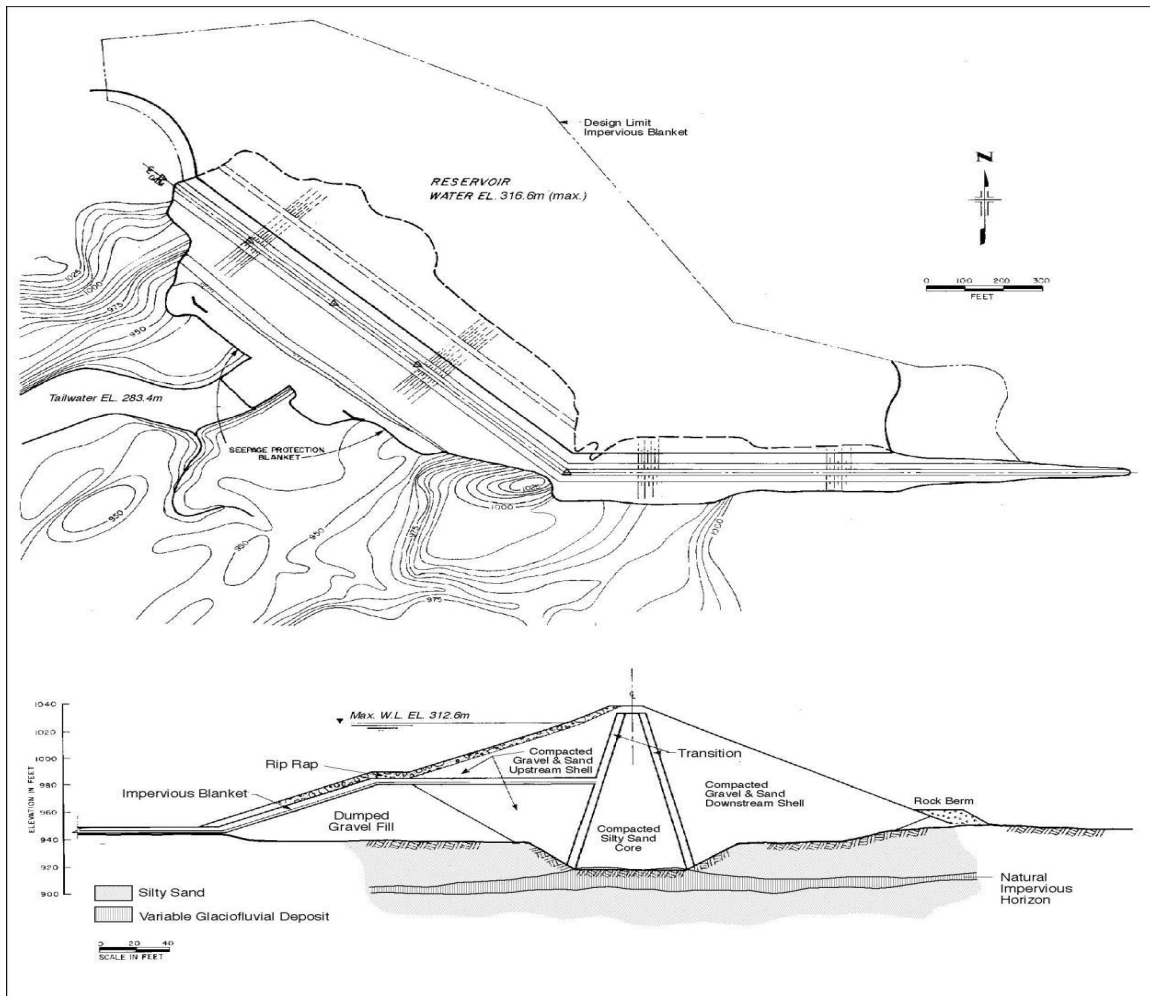
Shikwamkwa dam was completed in 1958 in Ontario, Canada, [10]. The cross-section is shown in Figure 9. It was a 35 m zoned earthfall dam with a central impervious core constructed using a fine silt material (rock flour). The dam was founded on a deep, permeable and highly variable interbedded glaciofluvial and glaciolacustrine overburden deposits that ranged from cohesionless silts to coarse deposits of nested cobbles and boulders. The primary defense against foundation seepage was a relatively short (about six times the head) and thin (about 3% of the hydraulic head) impervious blanket that connected to the central core and what was thought to be a relatively continuous layer of relatively impervious silty sands in the dam foundation. [6]

Figure 9. Shikwamkwa Dam: Section and plan showing the extent of upstream blanket, [10].

During impounding in 1958 numerous seepage incidents occurred with leakage up to  $1.0 \text{ m}^3/\text{s}$  and local instability on the downstream slope. Toe berms and additional blankets were added, and the dam performed satisfactorily for about ten years. Then downstream sand boils, piping incidents and sinkholes re-commenced, including one sinkhole which in 1971 opened up at the toe of the upstream slope, causing a slope failure, which fortunately did not break through the dam crest. A record of this event (which after repair left a depression in the crest) and the many sinkholes, seepage routes, sand boils and other damage which occurred is shown in Figures 10 and 11.

Repairs were conducted to allow the life of the dam to be extended. The repairs program included a downstream filter blanket and a fully automated monitoring system consisting of piezometers, weirs and a turbidity meter.

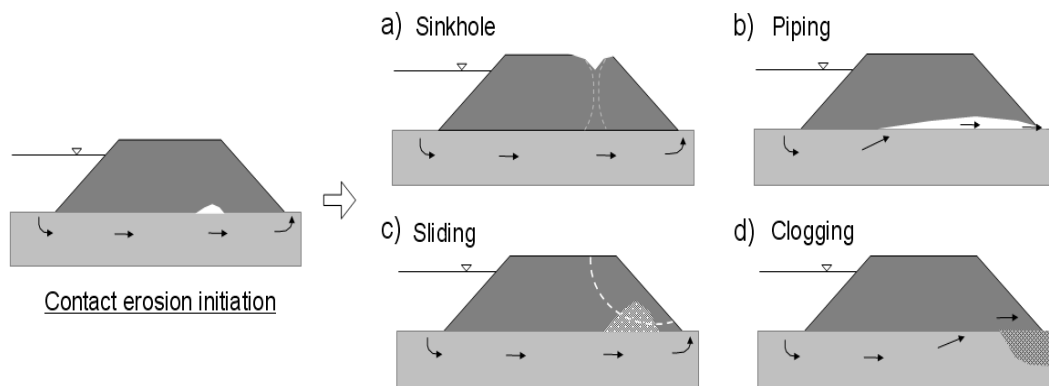
**Contact erosion** occurs when high river levels cause high velocities in the gravel foundation, sufficient to cause erosion at the contact with the silty fill of the dikes. The erosion of the fine fill seems to result in slow settlement of the dikes in such a manner that failure by overtopping is not expected. As Figure 12, shows, contact erosion results in most cases in sinkholes,

- a) cause piping in extreme cases (but never observed on site)
- b) leads to instability
- c) the fine particles accumulate and clog the gravel foundation at the toe,
- d) possibly causing hydraulic fracture and heave.

**Figure 12.** Consequences of contact erosion. Black arrows indicate a groundwater flow through a more permeable layer (light grey) under a less permeable dam (dark grey). a) sinkhole daylights b) beginning of backward erosion piping c) creation of a weaker zone initiating instability d) clogging of the permeable layer and increase of pore water pressure [11].

No incidents in collapse and failure of the dike were recorded. This may be explained cause the Darcy velocities were less than the critical limits (0.02 m/s), and the erosion was not continuous.
